2017 Culvert Assessment Report Tuftonboro, New Hampshire

The Lakes Region Planning Commission (LRPC) conducted a GPS inventory of culverts on Class V roads in Tuftonboro, NH. The inventory included not only GPS locations of culverts, but also collection of certain attributes related to the culvert (including overall condition) as identified in the Statewide Asset Data Exchange System (SADES) Data Collection Specification Guide for Culverts, updated and published in 2017 by UNH Technology Transfer Center in partnership with NH DES, NHDOT, and New Hampshire’s Regional Planning Commissions (Appendix A). This work was conducted under a contract with the town and with financial support through the NH DOT.

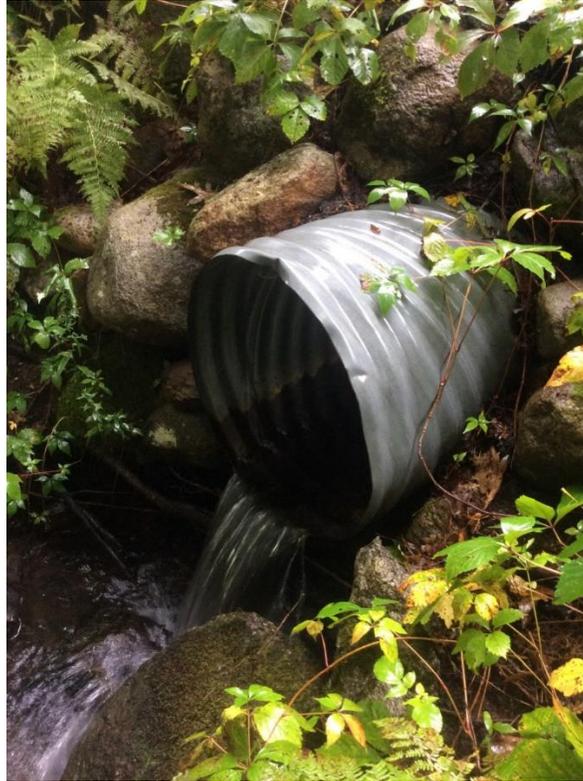
Picture taken on Willand Road during assessments in Tuftonboro, NH.

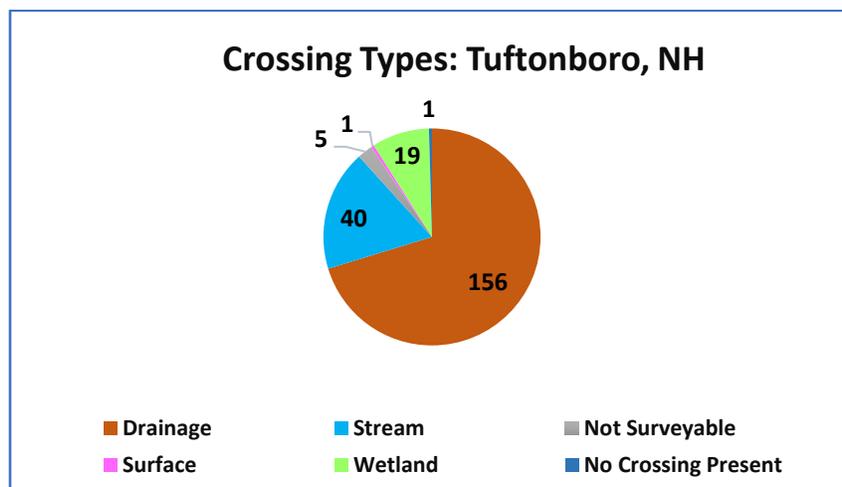
Figure 1: Total number of crossing types in Tuftonboro, NH.

After meeting with the Tuftonboro Road Agent, Selectmen, and Tuftonboro Conservation Commission Chair, for reviewing the methodology for culvert assessments, three trained transportation technicians under the supervision of LRPC staff located and assessed 222 culverts and catch basin inlets. Assessments took place between August 25, 2017 and September 11, 2017 with Quality Assurance/Quality Control (QA/QC) through September. Figure 1 below shows that of the 222 structures, about 70% were considered to be drainage features (typically water is not present except in the case of a heavy rainfall), about 18% were culverts at the locations of streams (water is present most of the year and has defined banks), and the remaining were either surface water (pond or lake), wetlands (water is present most of the year and have no defined banks), or not surveyable for a variety of reasons (usually due to private property boundary lines). The crossing type and locations are shown in Map 1 “Tuftonboro, NH-Crossing Type 2017.” The summer of 2017 was quite rainy; as a result, many drainage culverts had some amount of water in them.

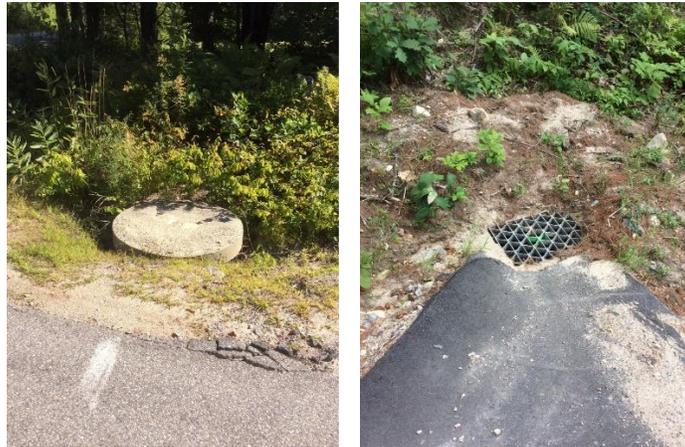
Figure 2: Examples of ‘Catch Basin Inlets’ in Tuftonboro, NH.
(Left: County Road, Right: Sodom Road)

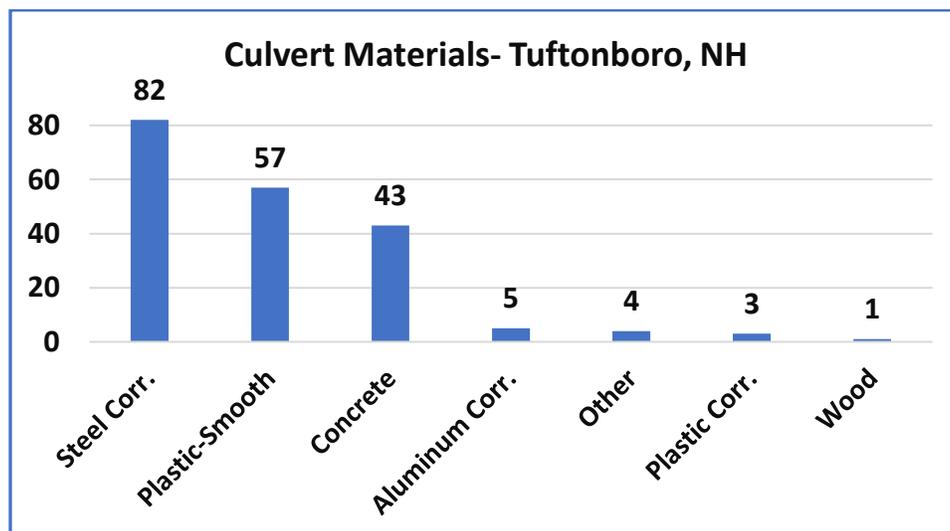
Figure 3: Number of Culverts in Tuftonboro, NH.

The features in Tuftonboro were found to be composed of six different types of materials. These include: steel corrugated, plastic-smooth, concrete, aluminum corrugated, plastic corrugated, and wood. Figure 3 summarizes the materials identified (not including the 27 catch basin inlet features) and illustrates that the most common material used in Tuftonboro’s culverts is corrugated steel (82 features), followed by plastic-smooth and concrete. Examples of these materials are shown in Figure 4. There were limited numbers of aluminum-corrugated, plastic-corrugated, and wood features. The location of these are shown in Map 3 “Tuftonboro, NH-Structure Materials.”

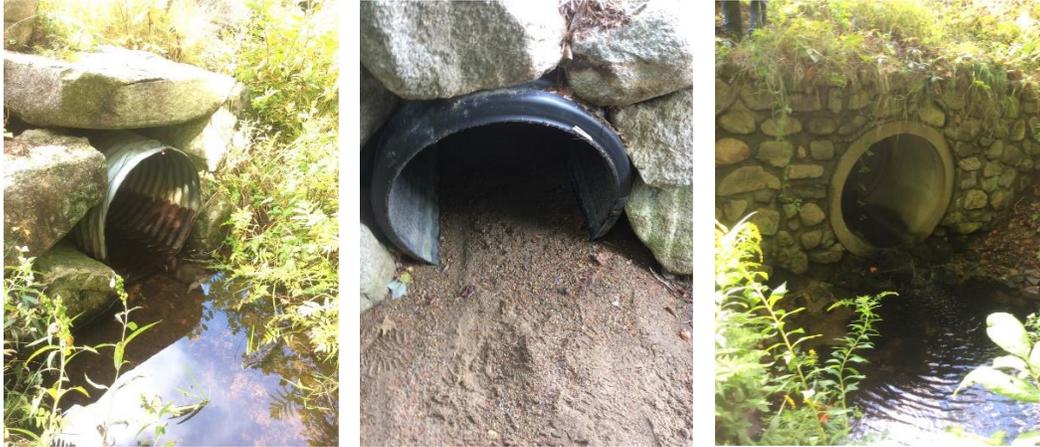
Figure 4: Examples of the most common culvert materials in Tuftonboro, NH.

(Left: Corrugated Steel on Dame Rd, Middle: Smooth Plastic* on Sodom Rd, Right: Concrete on Ledge Hill Rd)

*Determined by the inside surface of the pipe.

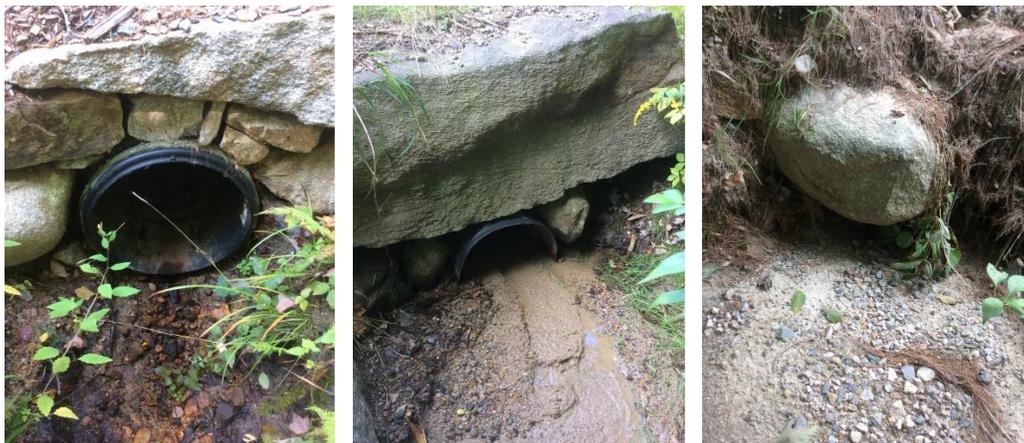
Culverts were assessed for the amount of sediment buildup, they were categorized into five groups (open, $\frac{1}{4}$ full, $\frac{1}{2}$ full, $\frac{3}{4}$ full, and entirely full). The majority of culverts that were assessed for sediment build up are ‘open’ and free of any obstructions. However, 45 of the 185 assessed structures (24.3%) were found to be at least half full. Examples of open, $\frac{1}{2}$ full, and entirely full culverts are shown in Figure 5. The locations of these are shown in Map 4 “Tuftonboro, NH – Structure Sediment Buildup.” Catch basin inlets and some other drainage features were not assessed for this specific attribute, due to inaccessibility.

Figure 5: Examples of various amounts of sediment build up in Tuftonboro, NH.

(Left: Open on Union Wharf Rd, Middle: $\frac{1}{2}$ Full on Phineas Graves Rd, Right: Full on Eglemere Rd.)

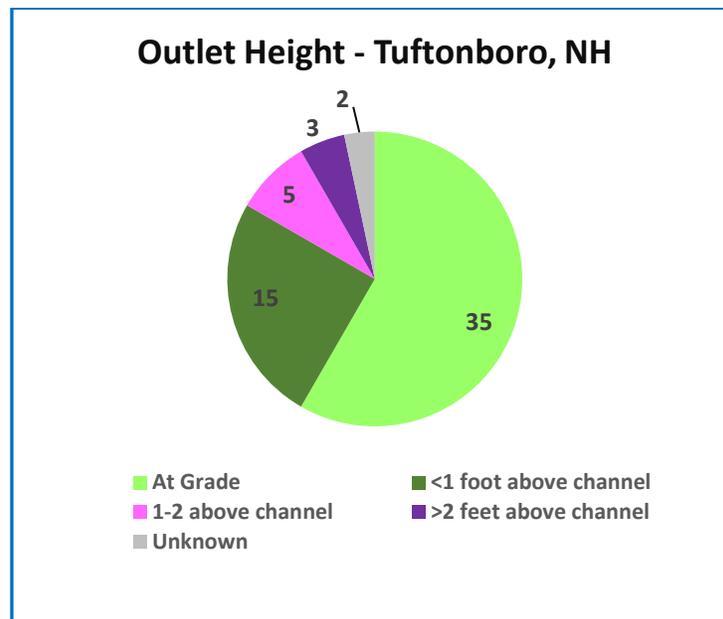
There are 5 culverts that show a significant amount of gravel runoff at water crossings and this was noted in the “comments” section. The locations of these are found in Map 5, “Outlet Height and Gravel Runoff at Water Crossings.” Outlet height was categorized into five groups: embedded, at grade, less than a foot above channel, 1-2 feet above channel, and more than 2 feet above channel. Figure 6 illustrates the number of culverts in each group at the locations of stream, wetland, and surface water crossings. About 60% are at grade and 25% are less than a foot above the channel. Map 5, “Outlet Height and Gravel Runoff at Water Crossings,” shows the locations of these various outlet heights.

Figure 6: Outlet height of culverts at streams, wetlands, and surface water crossings

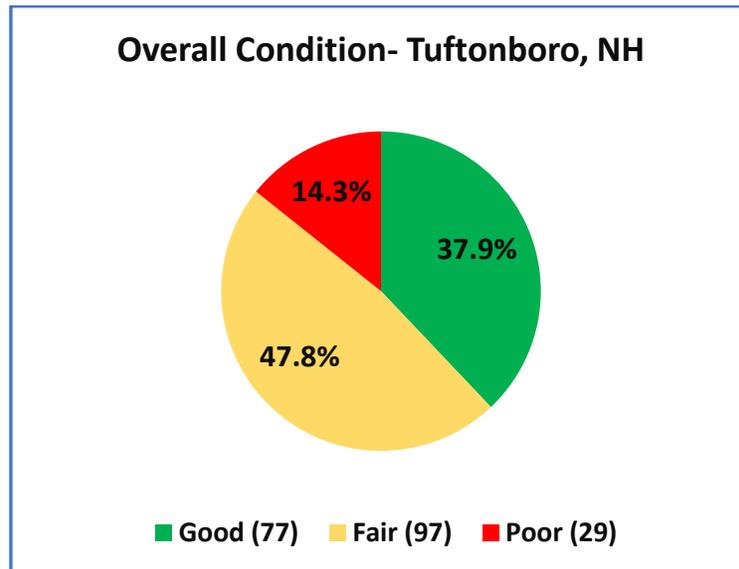
Figure 7: Overall condition of structures in Tuftonboro, NH.

At the end of each culvert and drainage feature assessment the field crew took into consideration the overall structure condition and categorize it as being: good, fair, or poor. Locations of these are illustrated in Map 6 “Tuftonboro, NH – Overall Condition.” About 86% of the structures in Tuftonboro are considered to be in good or fair condition, but nearly 14% were characterized as “poor” overall structure condition (Figure 7).

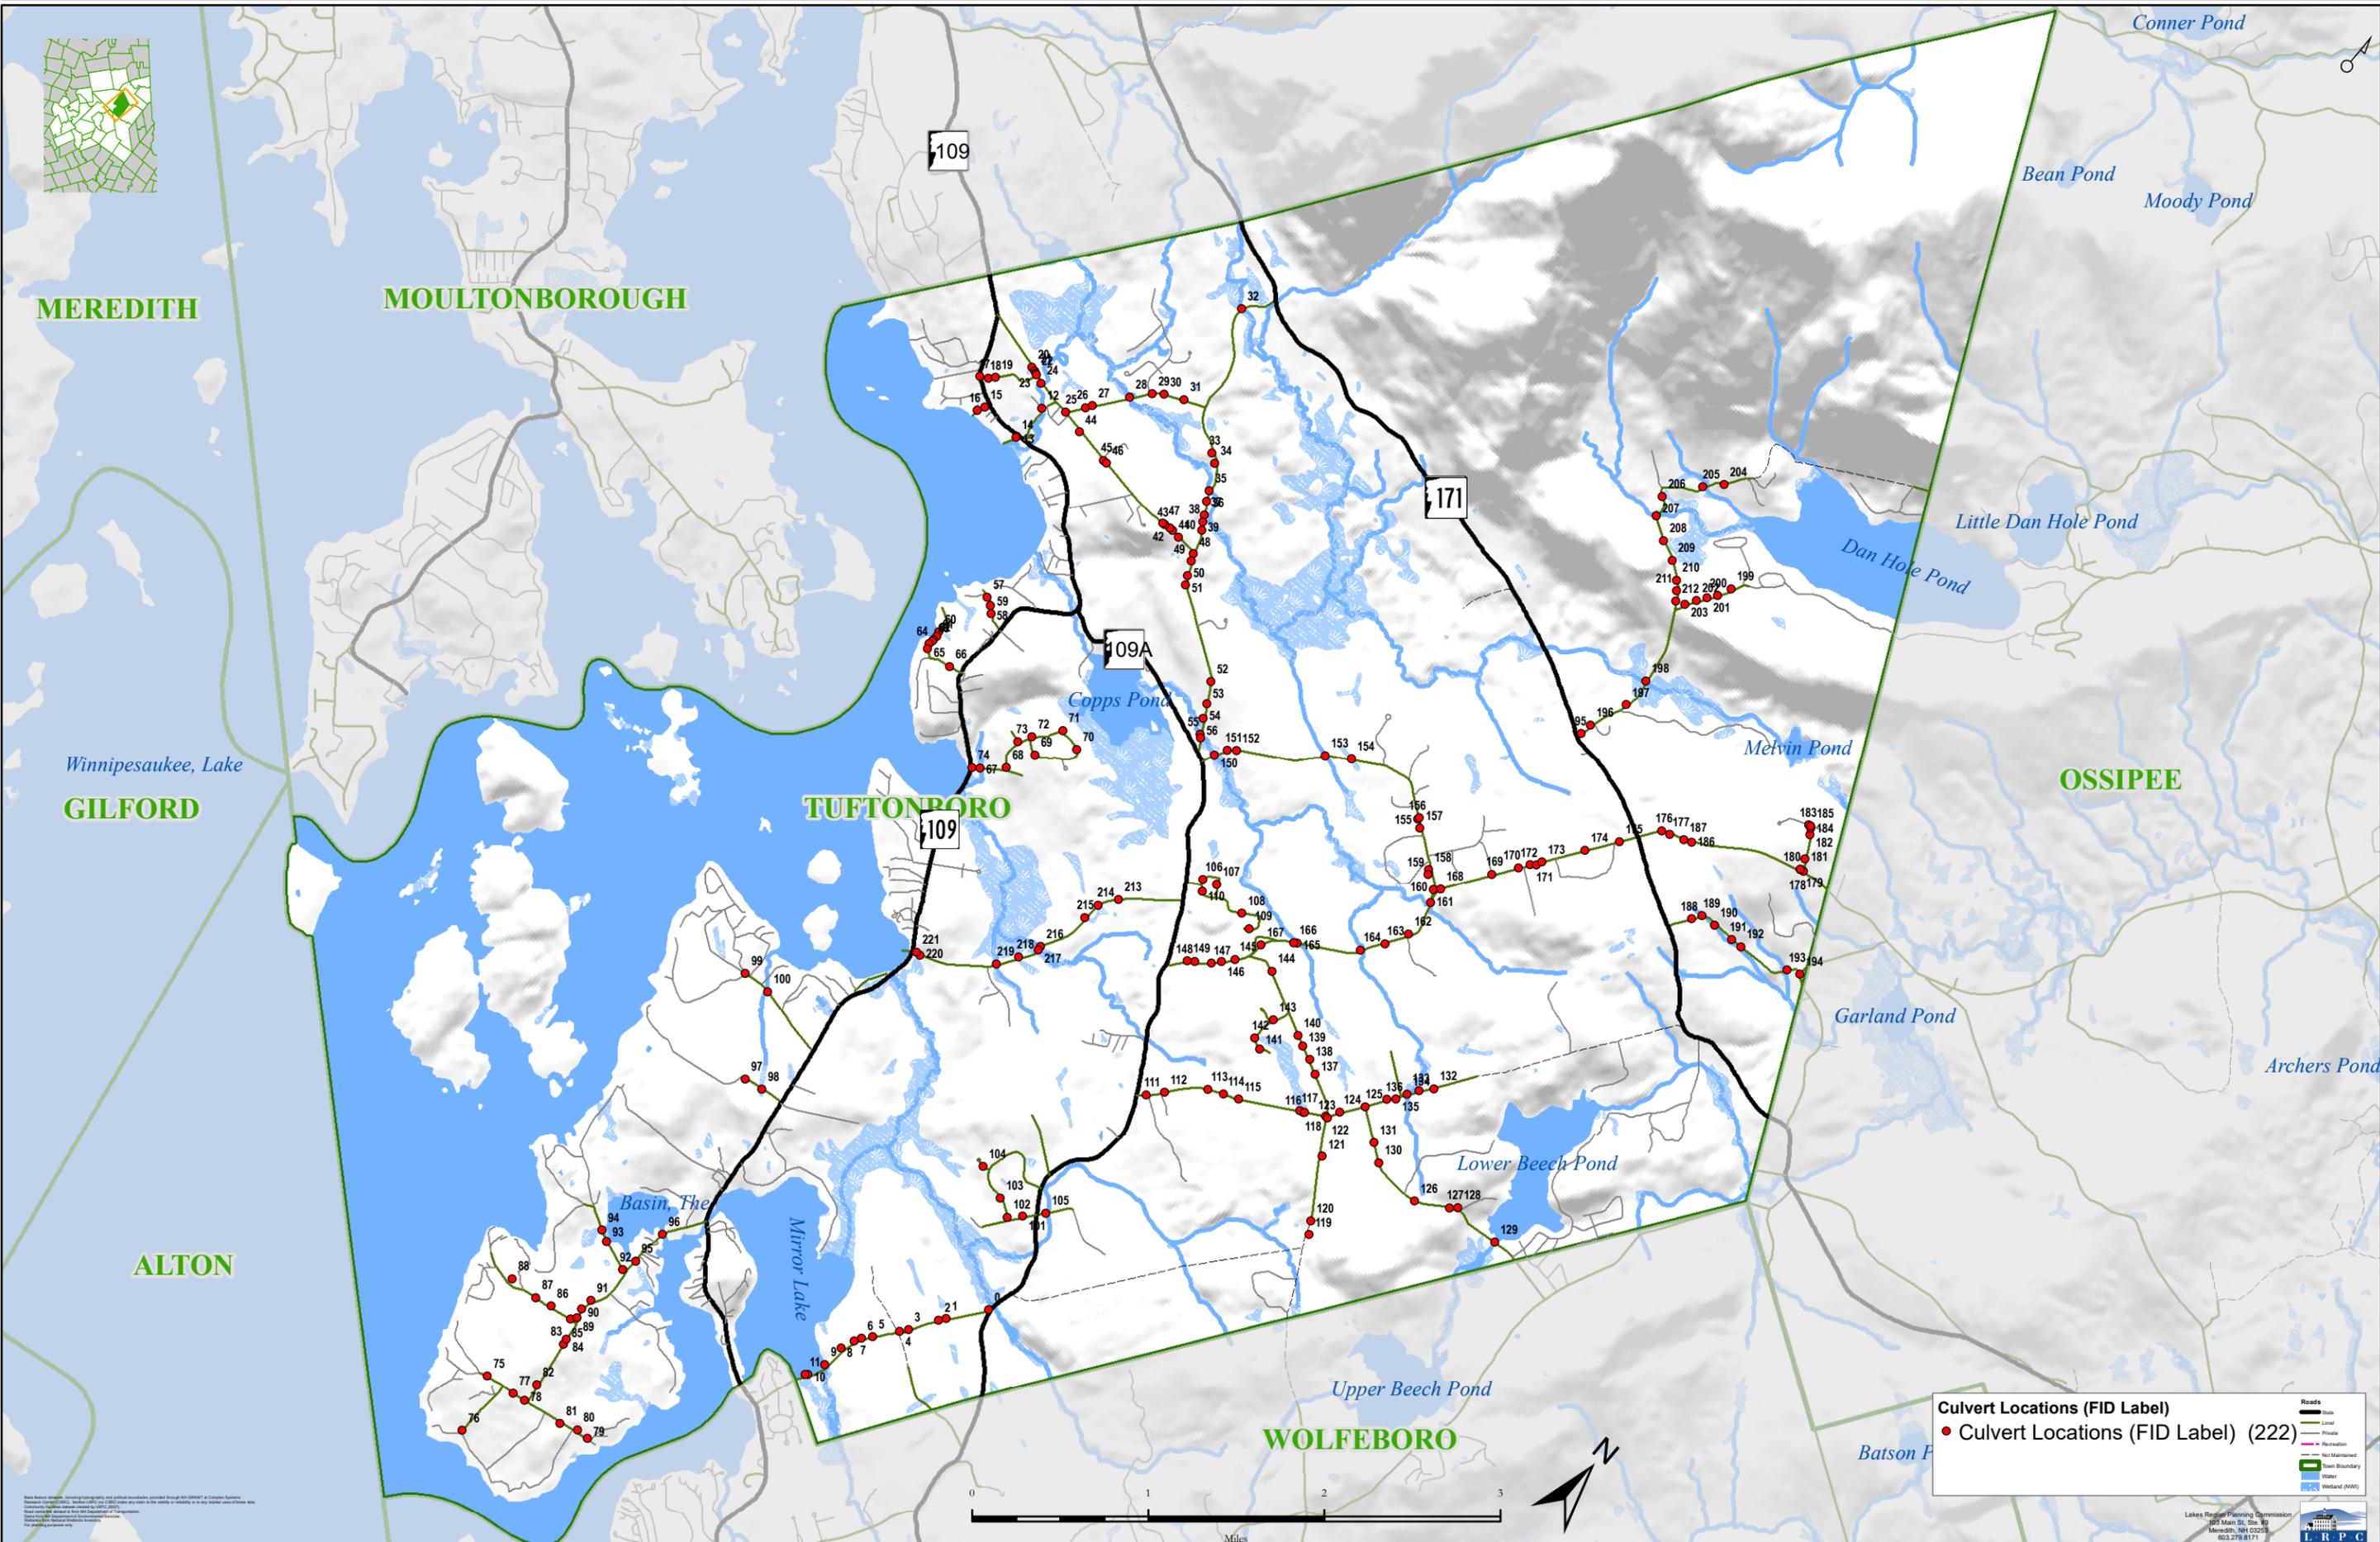
Culvert Locations (FID Label)
● Culvert Locations (FID Label) (222)

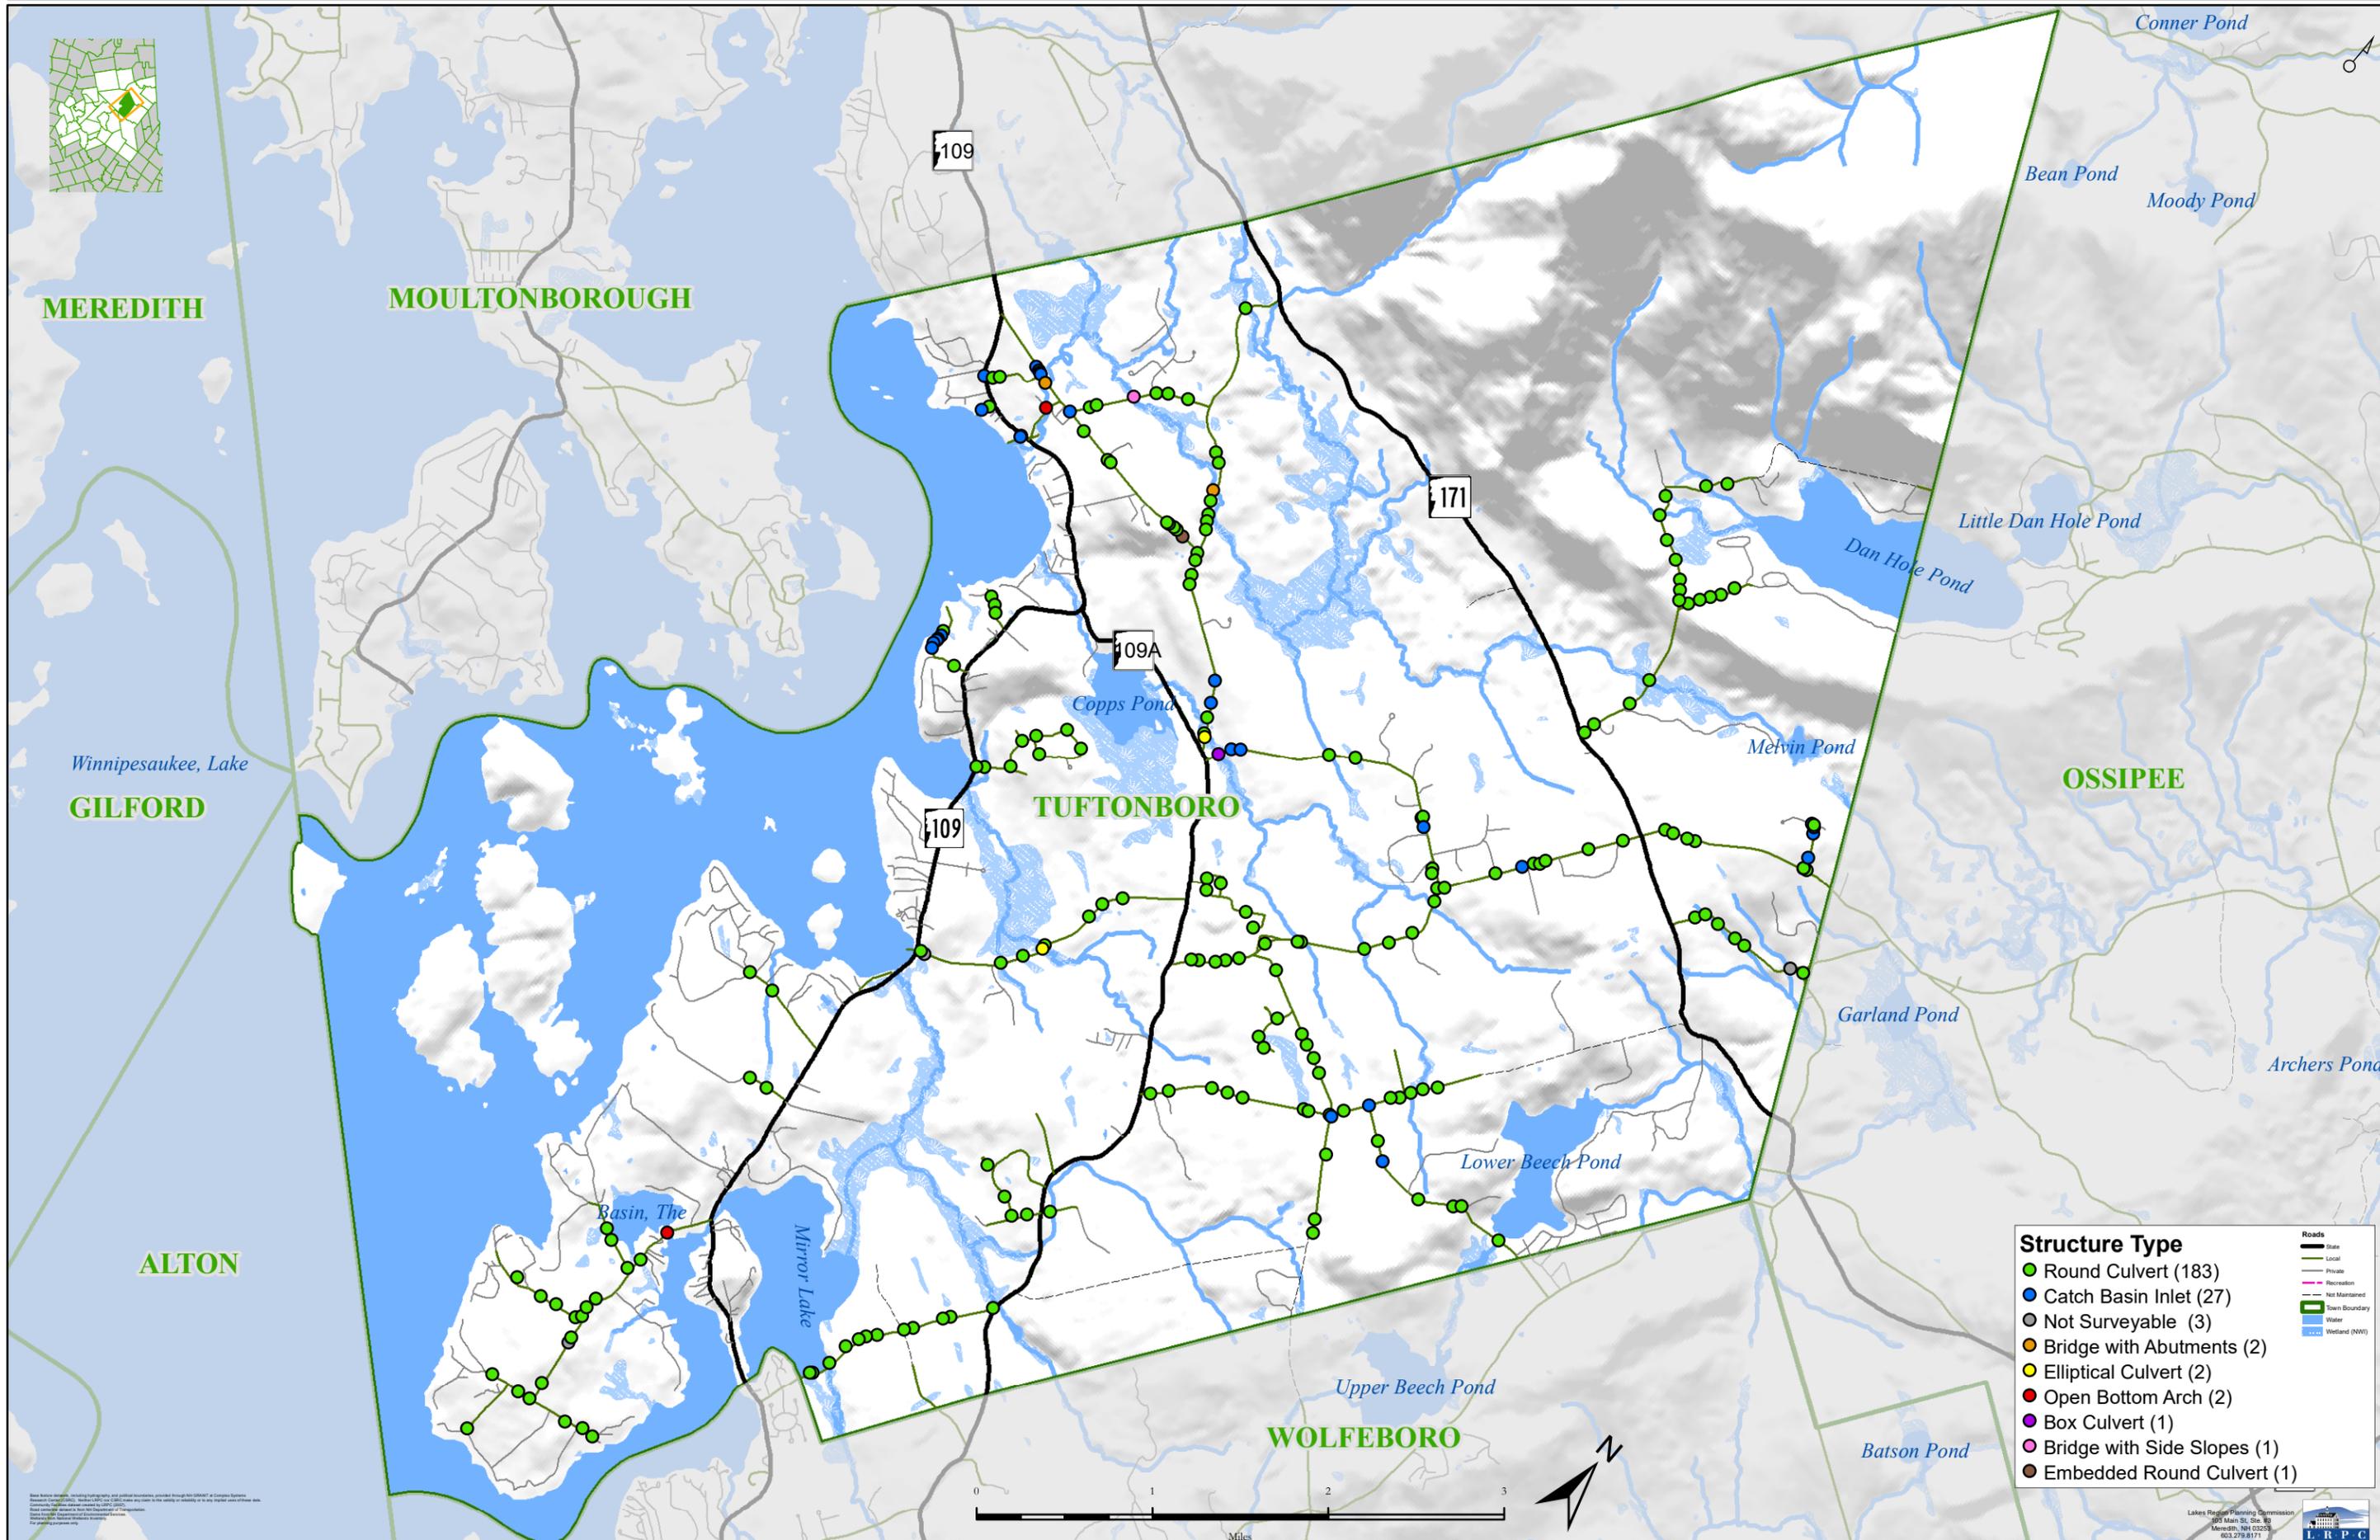
| Structure Type | |
| ● | Round Culvert (183) |
| ● | Catch Basin Inlet (27) |
| ● | Not Surveyable (3) |
| ● | Bridge with Abutments (2) |
| ● | Elliptical Culvert (2) |
| ● | Open Bottom Arch (2) |
| ● | Box Culvert (1) |
| ● | Bridge with Side Slopes (1) |
| ● | Embedded Round Culvert (1) |

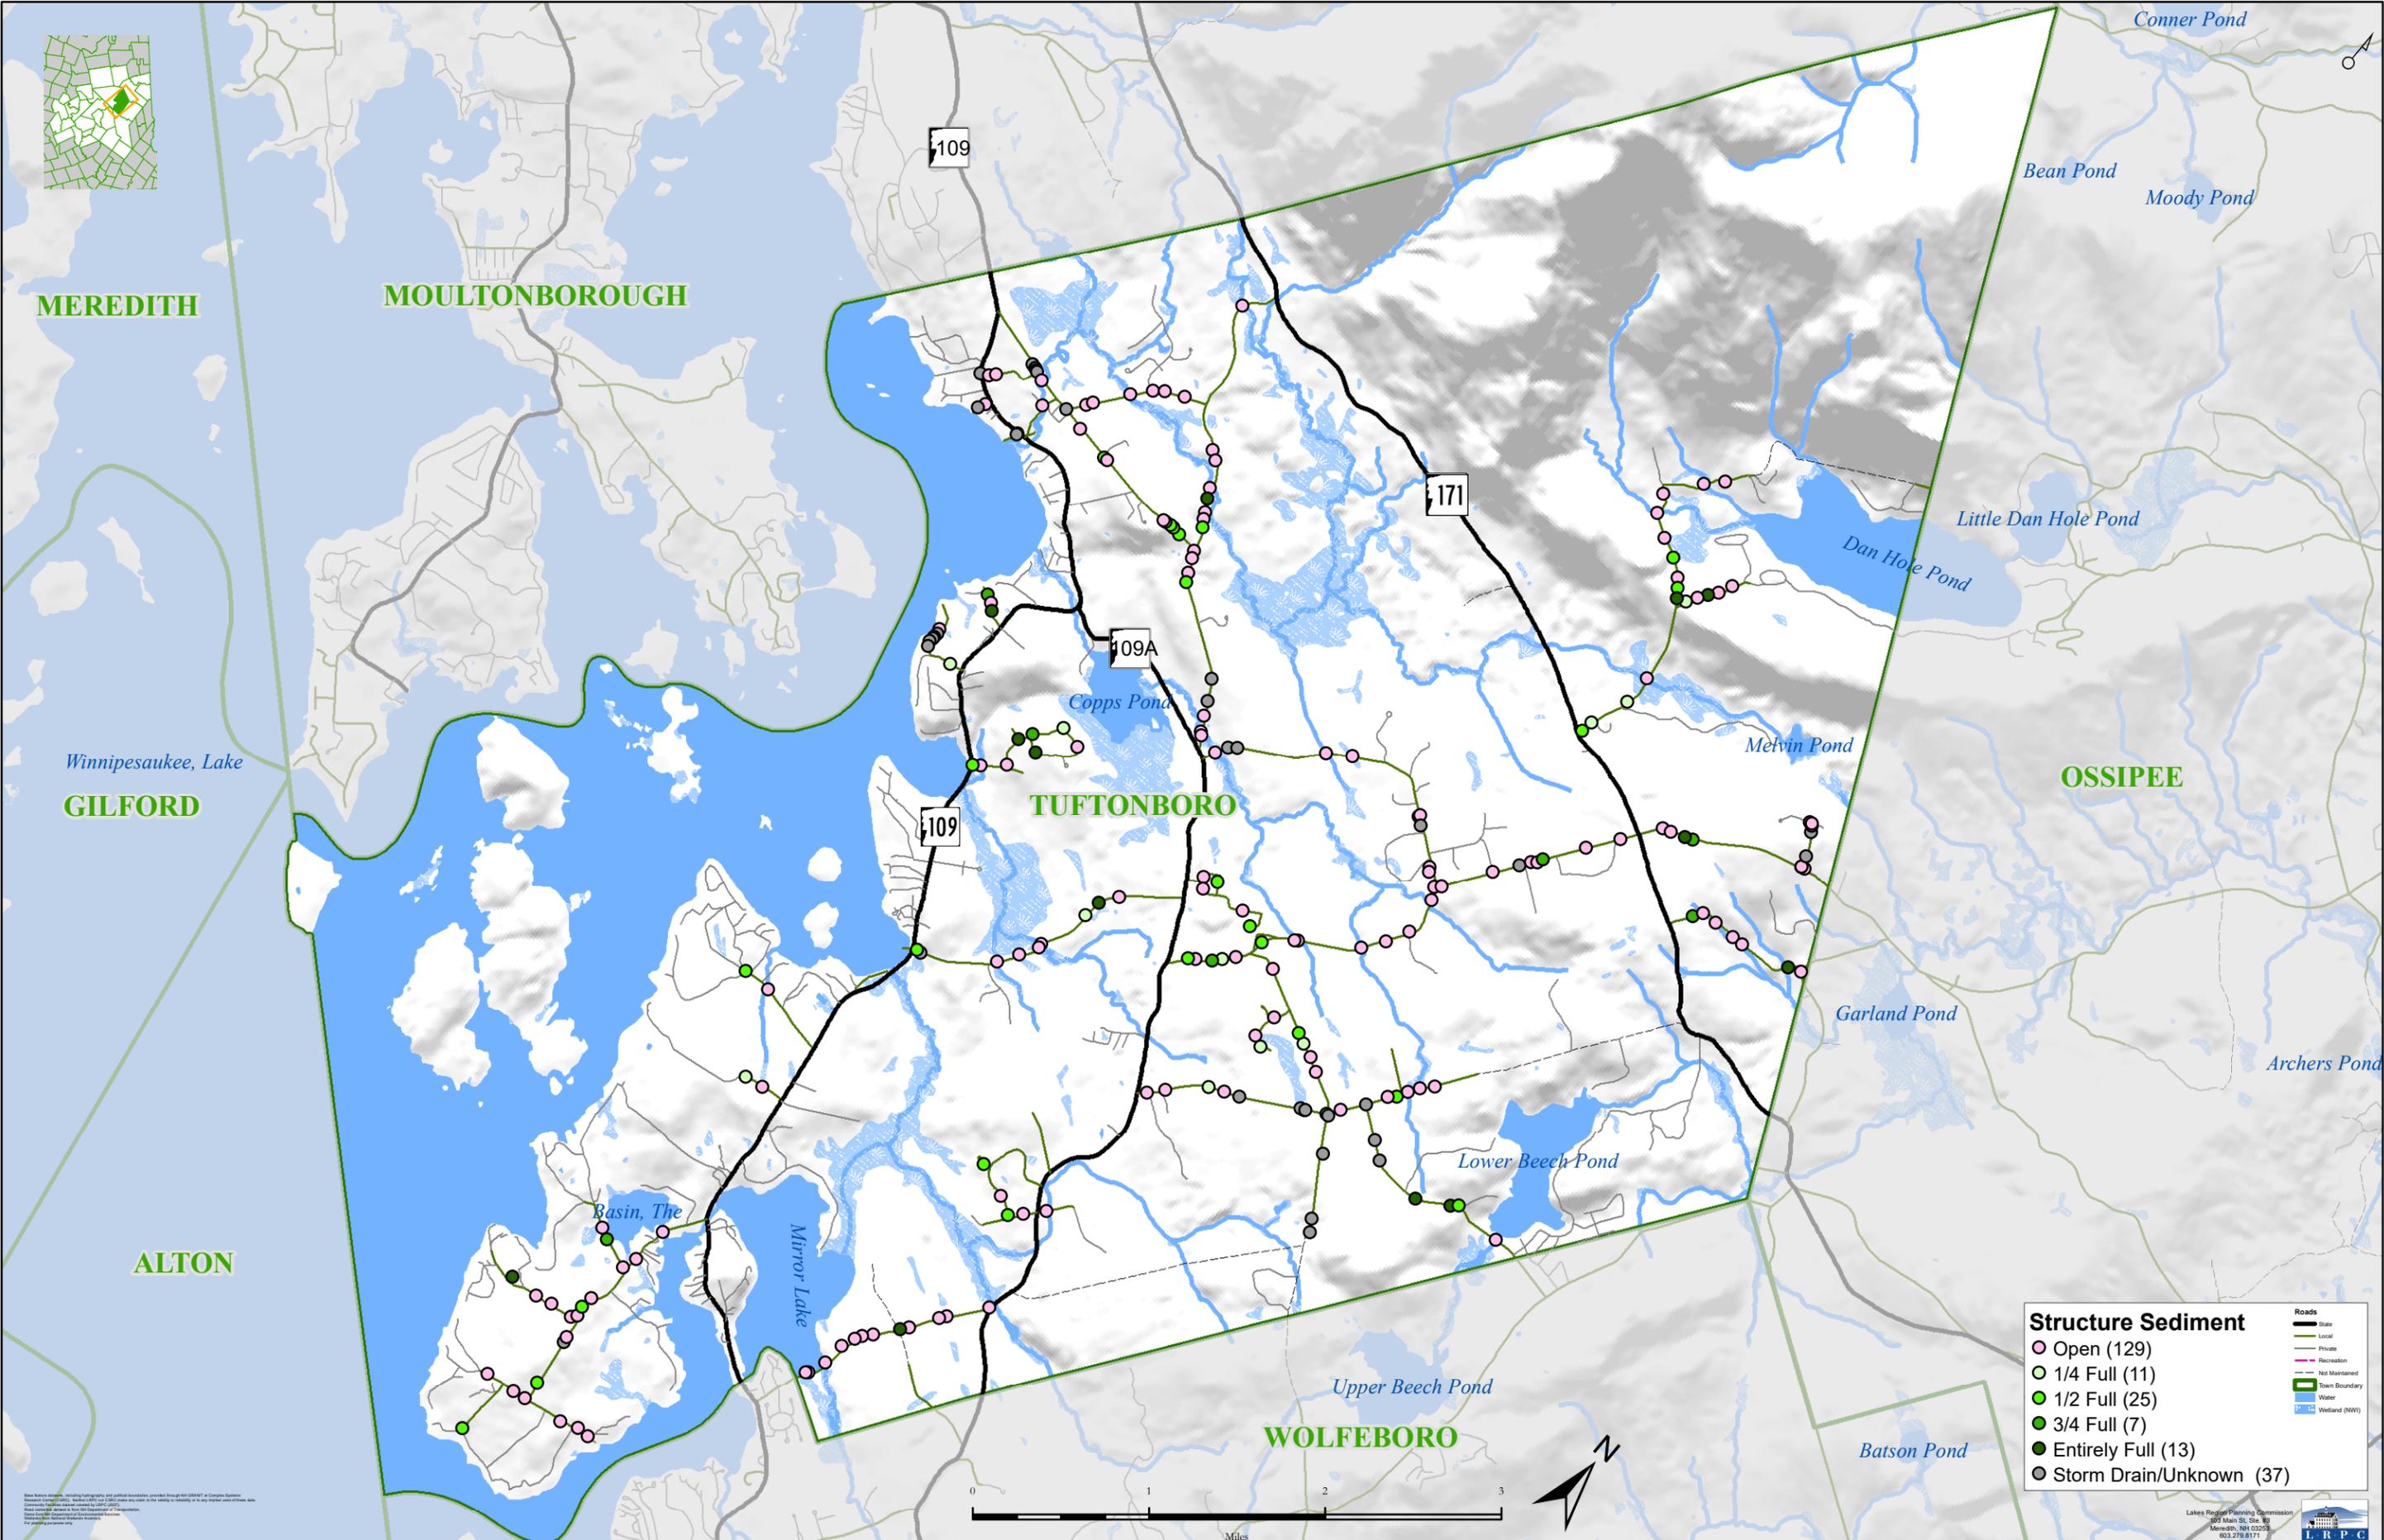
Structure Sediment

- Open (129)
- 1/4 Full (11)
- 1/2 Full (25)
- 3/4 Full (7)
- Entirely Full (13)
- Storm Drain/Unknown (37)
