**Nineteen Mile Brook
2019 Baseline Environmental Assessment
Aquatic Biota and Water Quality
Tuftonboro, NH**

Submitted By
Normandeau Associates, Inc.
25 Nashua Road
Bedford, NH 03110-5500
603.472.5191
www.normandeau.com

February 11, 2020

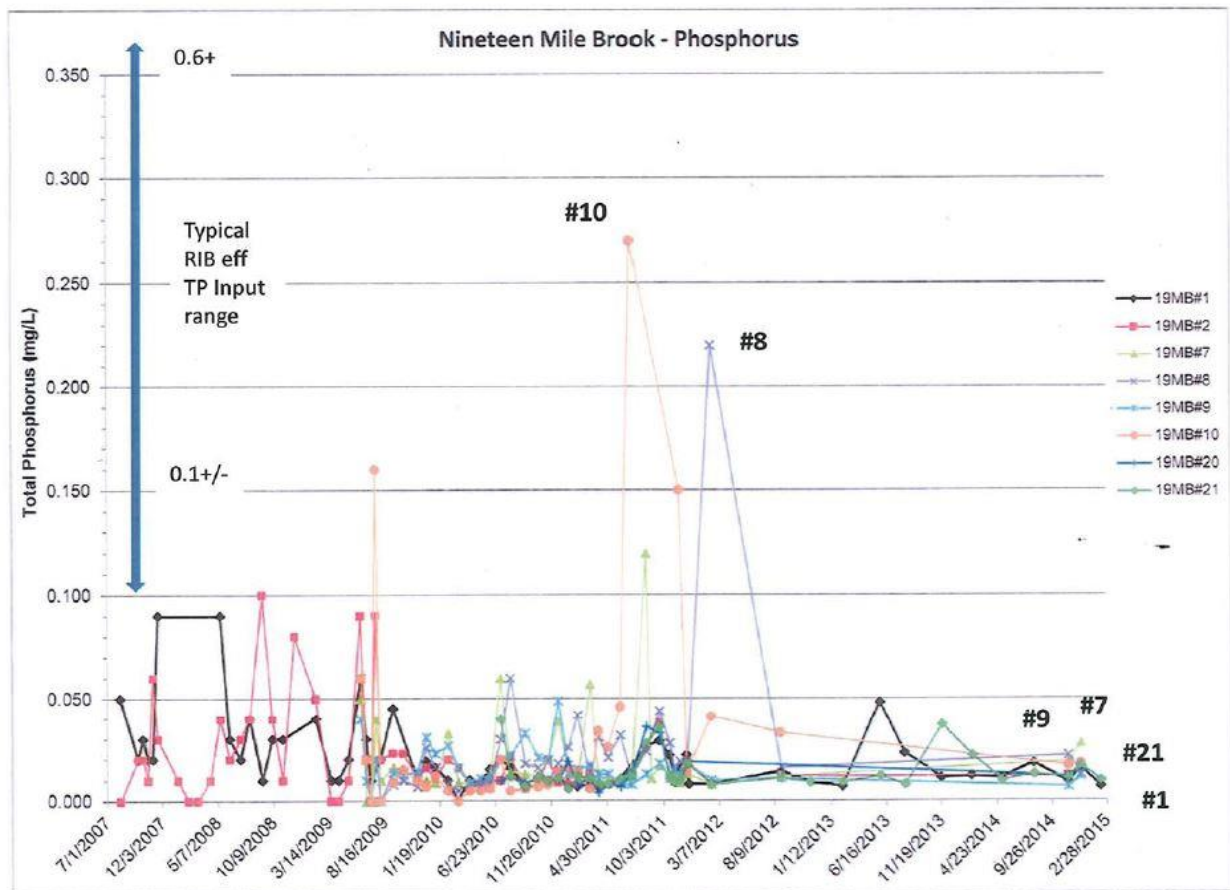
Figure 4. Total phosphorus at all GWP monitoring stations except 19MB-4 for 2007 – 2015 (from Wolfeboro, 2015)

In the available water quality data for Nineteen Mile Brook, there were routine exceedances of the 0.010 mg/L TP threshold throughout the watershed and throughout the period of record from 2007 – 2017 (see Figures 4 & 5). In the data reviewed there were 483 samples out of a total of 756 samples reviewed (64%) that exceeded the 0.01 mg/L TP threshold from 2007 – 2017. The available data also show that total phosphorus was variable throughout the Site and that high levels of TP were documented at the control reach (Station 19MB-1) outside the influence of the discharge and also at multiple stations in the timeframe pre-dating the operation of the discharge. These results suggests that TP sources in Nineteen Mile Brook are not confined to the RIB discharge area and that upstream watershed sources of TP (e.g. as documented at Station 19MB-1) are routinely in exceedance of the EPA guideline. The data reviewed indicate a highly variable pattern with an overall decreasing trend in TP levels throughout the watershed. Total phosphorus values in the watershed did not show strong evidence of spatial patterns of distribution, although there were some minor patterns evident. On average, TP concentrations were slightly higher in the Central and Western Groundwater Discharge Area stations compared to stations along the main stem of Nineteen Mile Brook. This suggests some evidence of minor TP effects from the RIB discharge in the Groundwater Discharge Areas, although the averages are only marginally higher and should not be considered significant. These results are expected as the wastewater entering the RIB structures is treated to reduce TP into the range of 0.1 – 0.6 mg/L (Wolfeboro, 2015) and the groundwater infiltration should serve to further reduce TP levels as phosphorus is readily attenuated in groundwater (in contrast with nitrogen which is highly mobile).

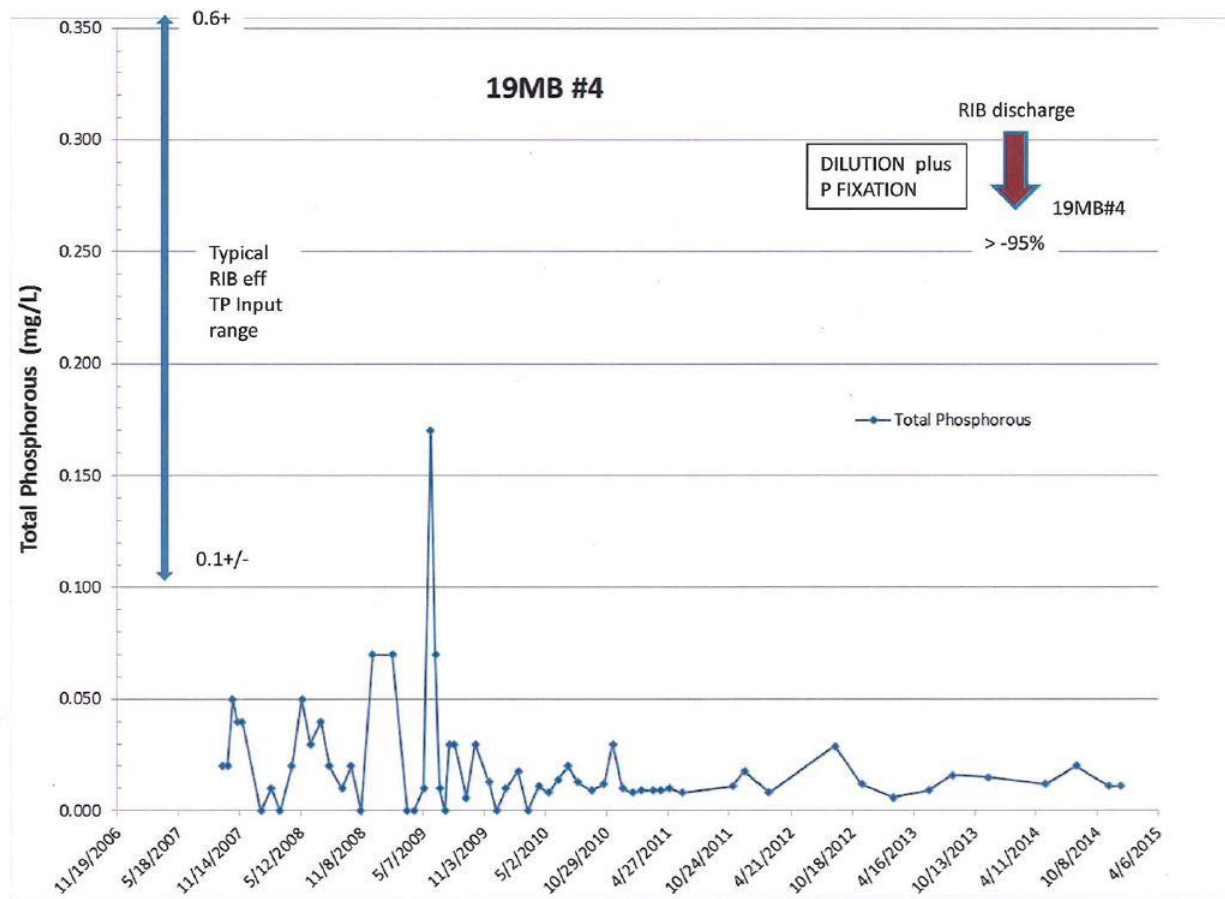
Figure 5. Total phosphorus at GWP monitoring station 19MB-4 for 2007 – 2015 (from Wolfeboro, 2015)

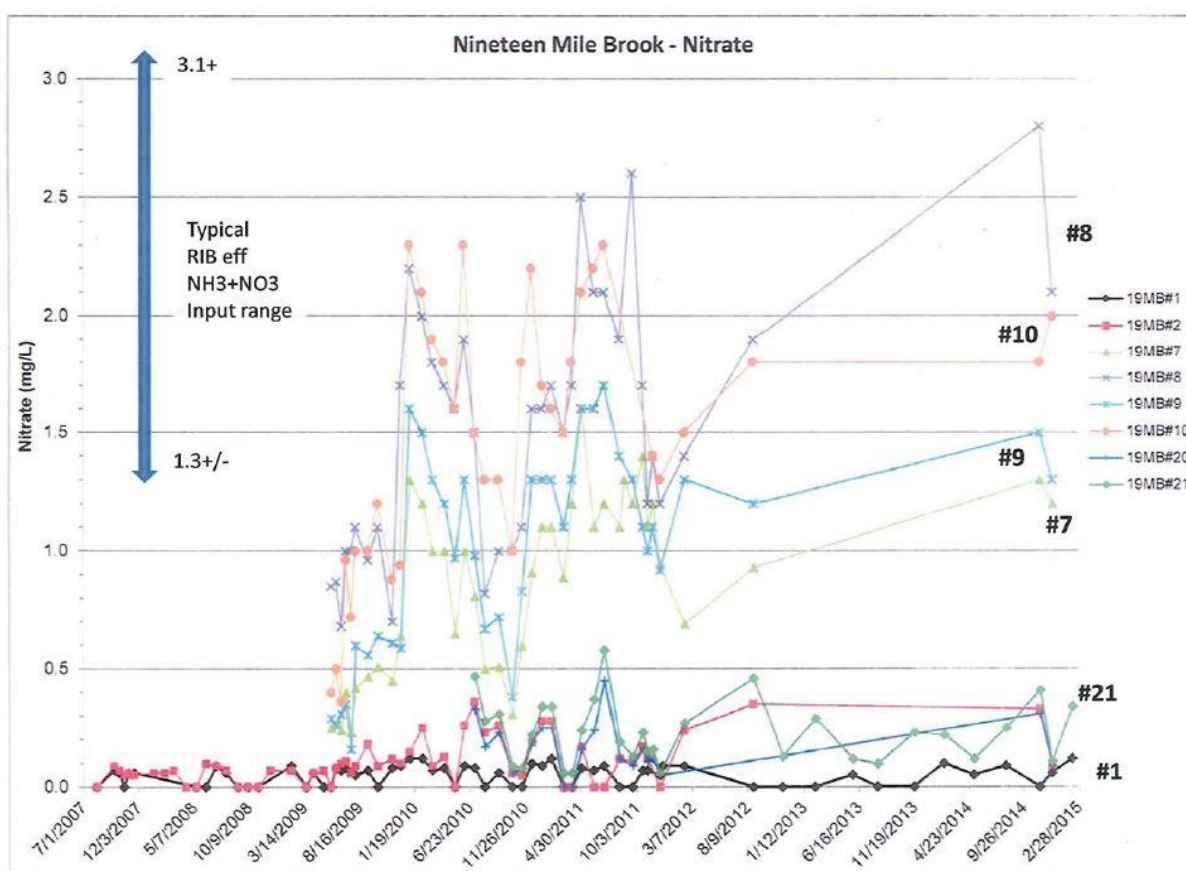
Figure 6. Nitrate at all GWP monitoring stations except 19MB-4 for 2007 – 2015 (from Wolfeboro, 2015)

Nineteen Mile Brook had the highest nitrate levels near Station 19MB-21, below the groundwater discharge areas, and the lowest nitrate levels at Station 19MB-01, the background station above the influence of the RIB discharge. The most consistently high levels of nitrate were measured in samples from the uppermost stations in the Western and Central Groundwater Discharge Areas (19MB-08 and 19MB-10, respectively). The median nitrate value for all samples from Station 19MB-08 was 1.1 mg/L, while at Station 19MB-10 it was 1.8 mg/L. These values were over an order of magnitude greater than the median nitrate value at Station 19MB-01 (background station) of 0.07 mg/L. Clearly, nitrate levels in Nineteen Mile Brook increased with commencement of operations of the RIB discharge and increased most significantly in the surface water tributaries receiving groundwater discharges in the Western and Central Groundwater Discharge Areas. This result is expected as nitrate is highly mobile in groundwater and high values would be expected in the discharge areas.

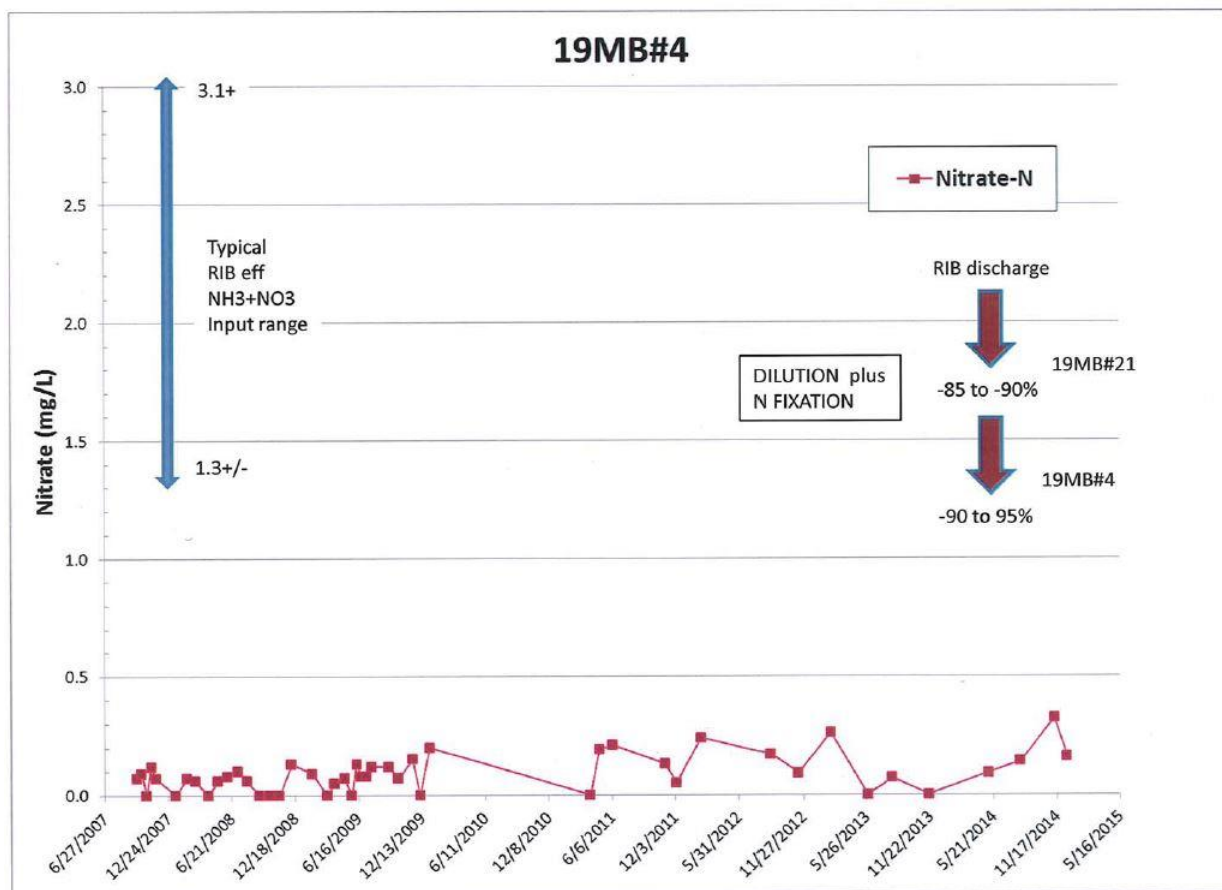
Figure 7. Nitrate at GWP monitoring station 19MB-4 for 2007 – 2015 (from Wolfeboro, 2015)

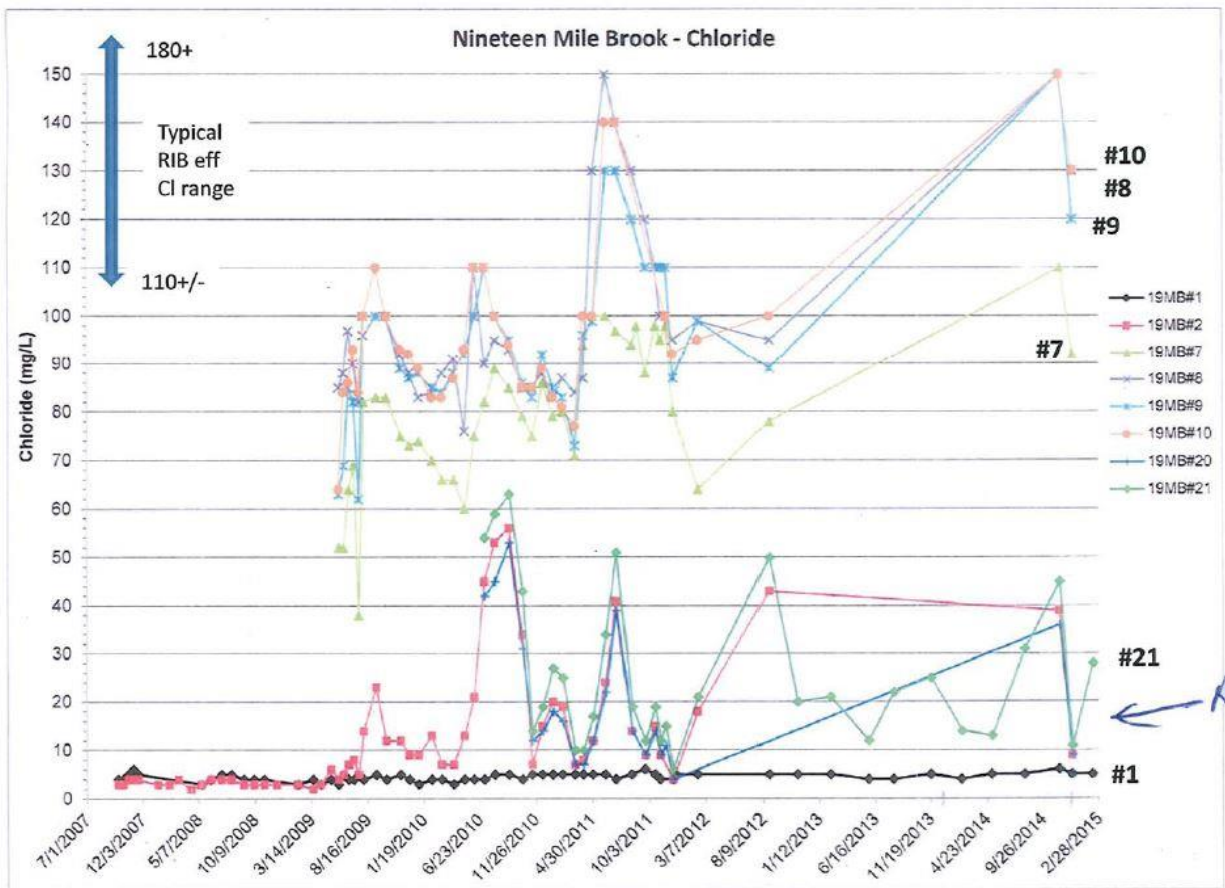
Figure 8. Chloride at all GWP monitoring stations except 19MB-4 for 2007 – 2015 (from Wolfeboro, 2015)

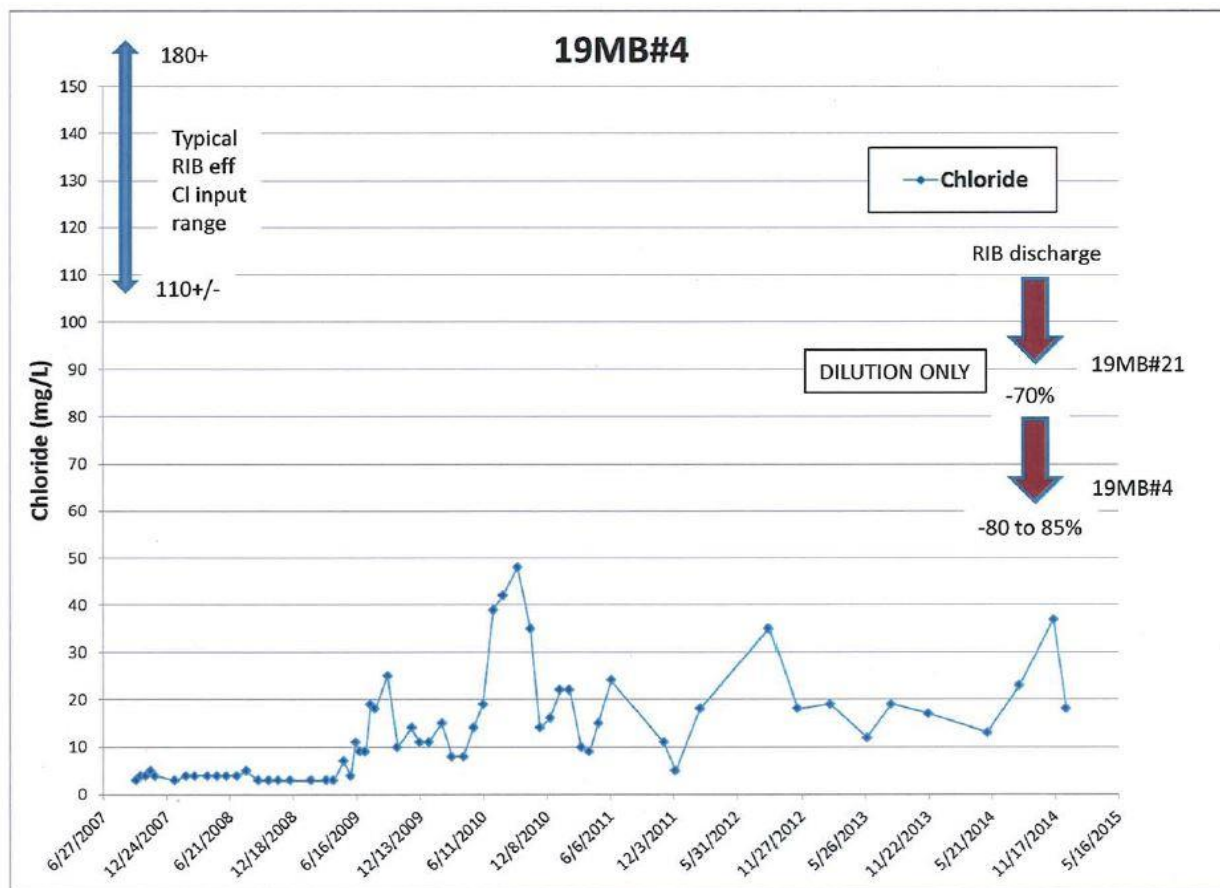
Figure 9. Chloride at GWP monitoring station 19MB-4 for 2007 – 2015 (from Wolfeboro, 2015)

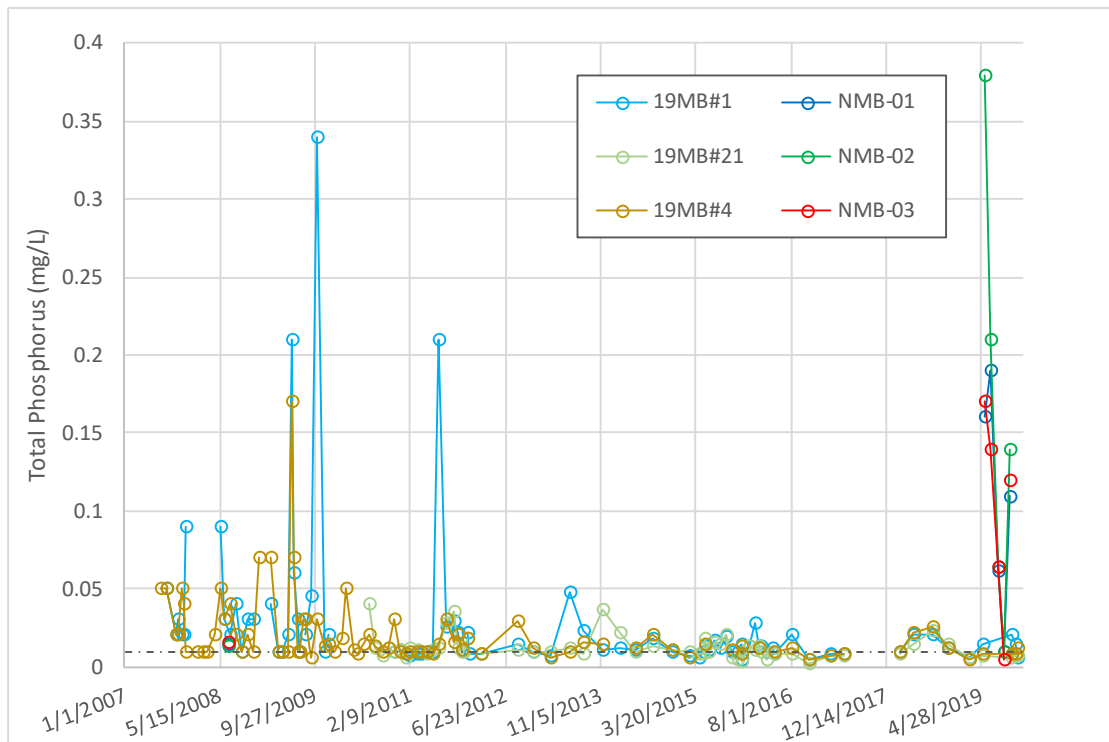
Figure 10. Wolfeboro GWP total phosphorus data (19 MB#1; 19MB#21; 19MB#4, 2007 – 2019); NAI total phosphorus data (NMB-01; NMB-02; NMB-03, 2008 & 2019)

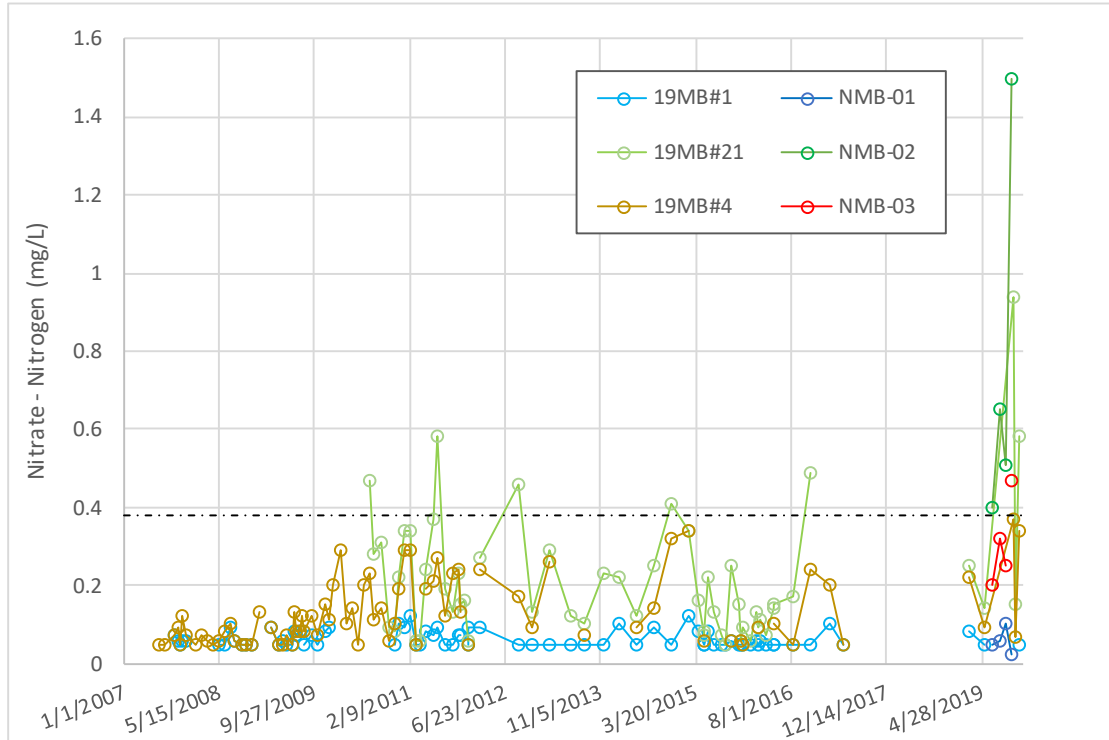
Figure 11. Wolfeboro GWP Nitrate - Nitrogen data (19 MB#1; 19MB#21; 19MB#4, 2007 – 2019); NAI Nitrate - Nitrogen data (NMB-01; NMB-02; NMB-03, 2008 & 2019)

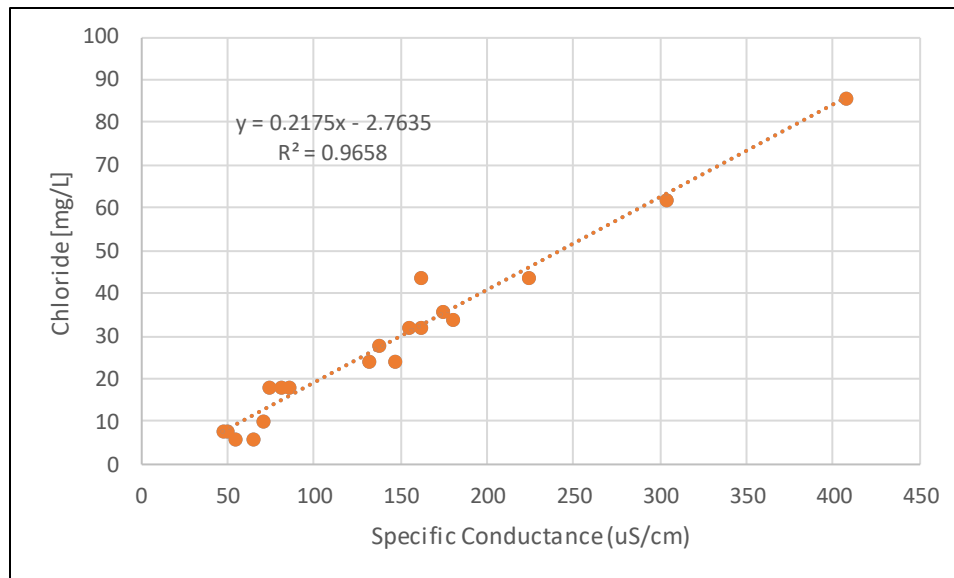
Figure 12. Chloride-specific conductance regression

Specific conductance data were also converted to an estimate of chloride concentration based on a linear regression developed from the chloride samples collected and analyzed for this study (n=19 valid chloride measurements) and the specific conductance readings of those samples as shown in Figure 12. Continuous temperature at each station is shown in Figure 13 (as a 24 hour rolling average to dampen large daily changes), specific conductance is shown in Figure 14 and estimated chloride concentrations are shown in Figure 15. Stream stage at NMB-02 and daily discharge from RIB structures are also shown in Figures 13 – 15 for reference.

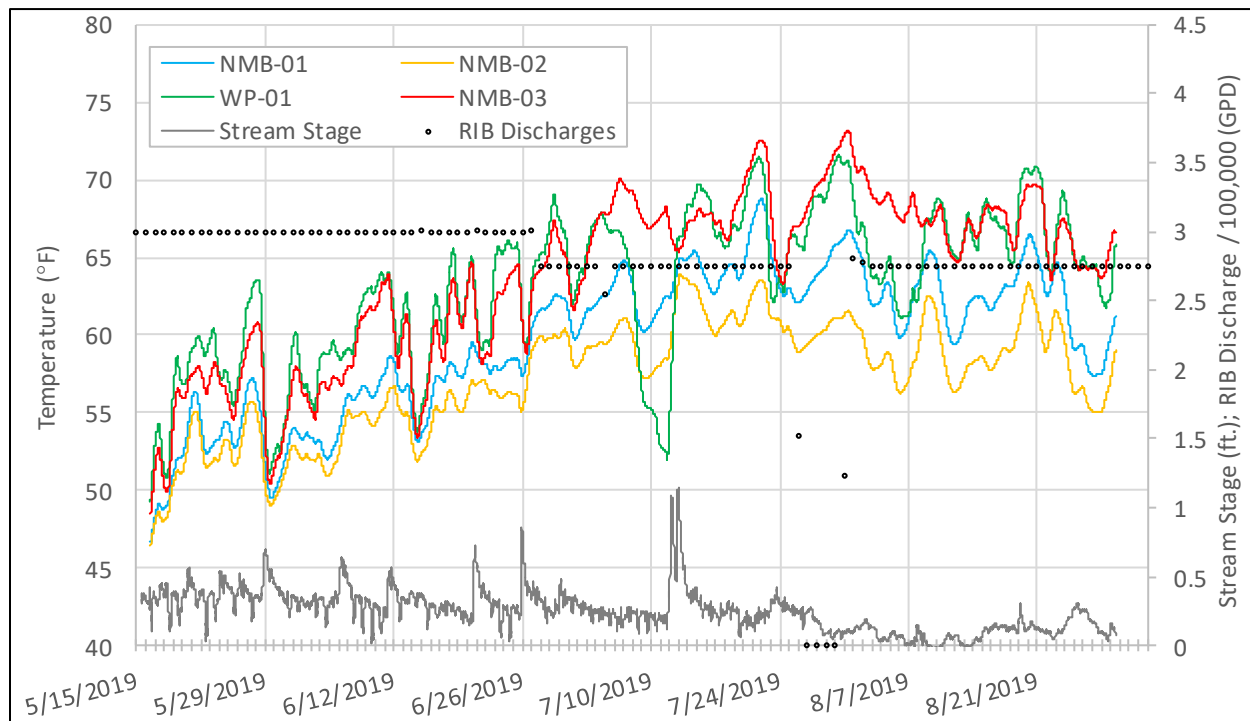
Figure 13. Water temperature at all sites as a 24 hour rolling average, stream stage at NMB-02, and RIB discharges

Our data show that water temperatures at Nineteen Mile Brook varied seasonally and daily, and in general were lower at the upper two sites (NMB-01 and NMB-02) compared to the lower two sites (WP-

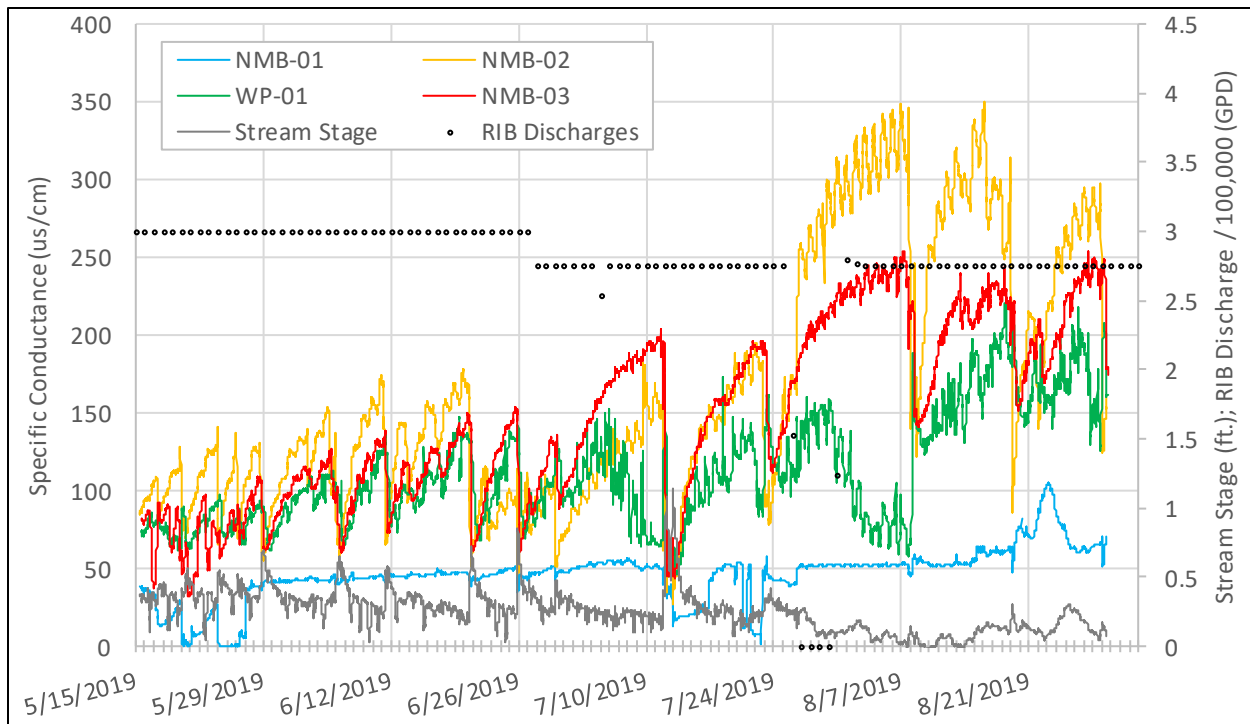
Figure 14. Specific conductance at all sites, stream stage at NMB-02, and RIB discharges

Specific conductance and estimated chloride values increased with decreasing streamflow throughout the study site, likely due to the shift in source composition at baseflows (i.e. increasingly from groundwater). The period from August 29 through September 25 that is missing from the continuous monitoring record was a very dry period and likely had continued periods of high specific conductance/chloride values in the stations at and below NMB-02. For comparison, see streamflow at the Bearcamp River at North Tamworth and stream stage at NMB-02 in Figure 16. Flows in late September were comparably low to flows in mid-August at the Bearcamp River, a surrogate for regional flow levels. At Nineteen Mile Brook specific conductance/ chloride may have been at a seasonal high in late September as evidenced by the grab sample from NMB-02 on September 25 that had a laboratory measured chloride value of 86 mg/L and a specific conductance reading in the field of 408 uS/cm. These levels were higher than any other readings measured during the study. While September data were not collected during the continuous monitoring study, and the highest measurements for specific conductance and chloride were measured at the end of that month, we think it is unlikely that levels in the stream were ever much higher than 400 uS/cm specific conductance and 86 mg/L chloride in this study period. Regionally, streamflow reached an absolute seasonal minimum in August (at Bearcamp River), not in September. Therefore we think it is reasonable to conclude that chloride levels in the stream never approached the state water quality standards of 230 mg/l (chronic) and 860 mg/L (acute) as this would be 2.5+ times greater than any measurement during our study, including the grab sample collected at the end of the September dry period. Therefore, while the missing data from our study are unfortunate, we don't feel that our results would change appreciably had the data been collected as planned.

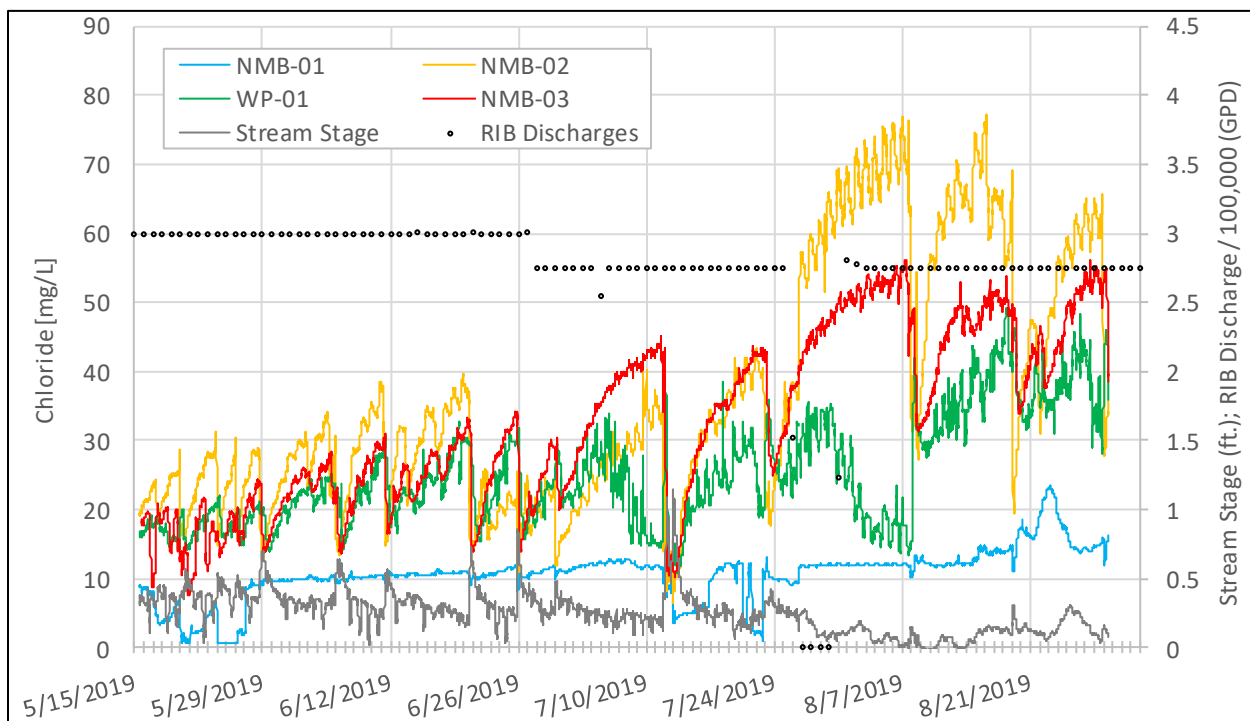
Figure 15. Estimated chloride at all sites, stream stage at NMB-02, and RIB discharges

Estimated chloride at each of the stations, as derived from the specific conductance data, followed identical patterns as the specific conductance data from which it was derived and is presented to review estimate chloride concentrations with respect to state standards. Estimated chloride during the May – August continuous monitoring period varied from 1 – 77 mg/L and was highest on average at NMB-02 with a mean estimated concentration of 36 mg/L for the study period. Estimated chloride values, while high for a typical low-order stream in this region, were well below the NH chronic (230 mg/L) and acute (860 mg/L) values for chloride.

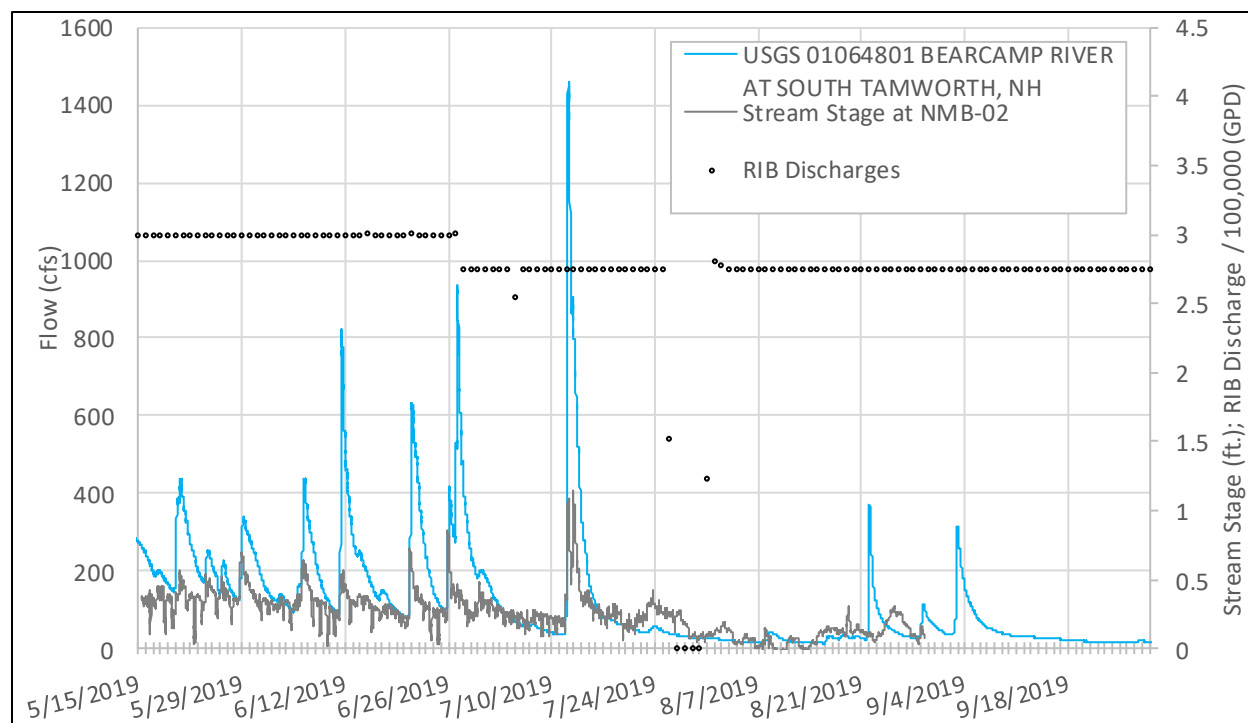
Figure 16. River flow at Bearcamp River at South Tamworth, NH (USGS gage 01064801), stream stage at NMB-02, and RIB discharges

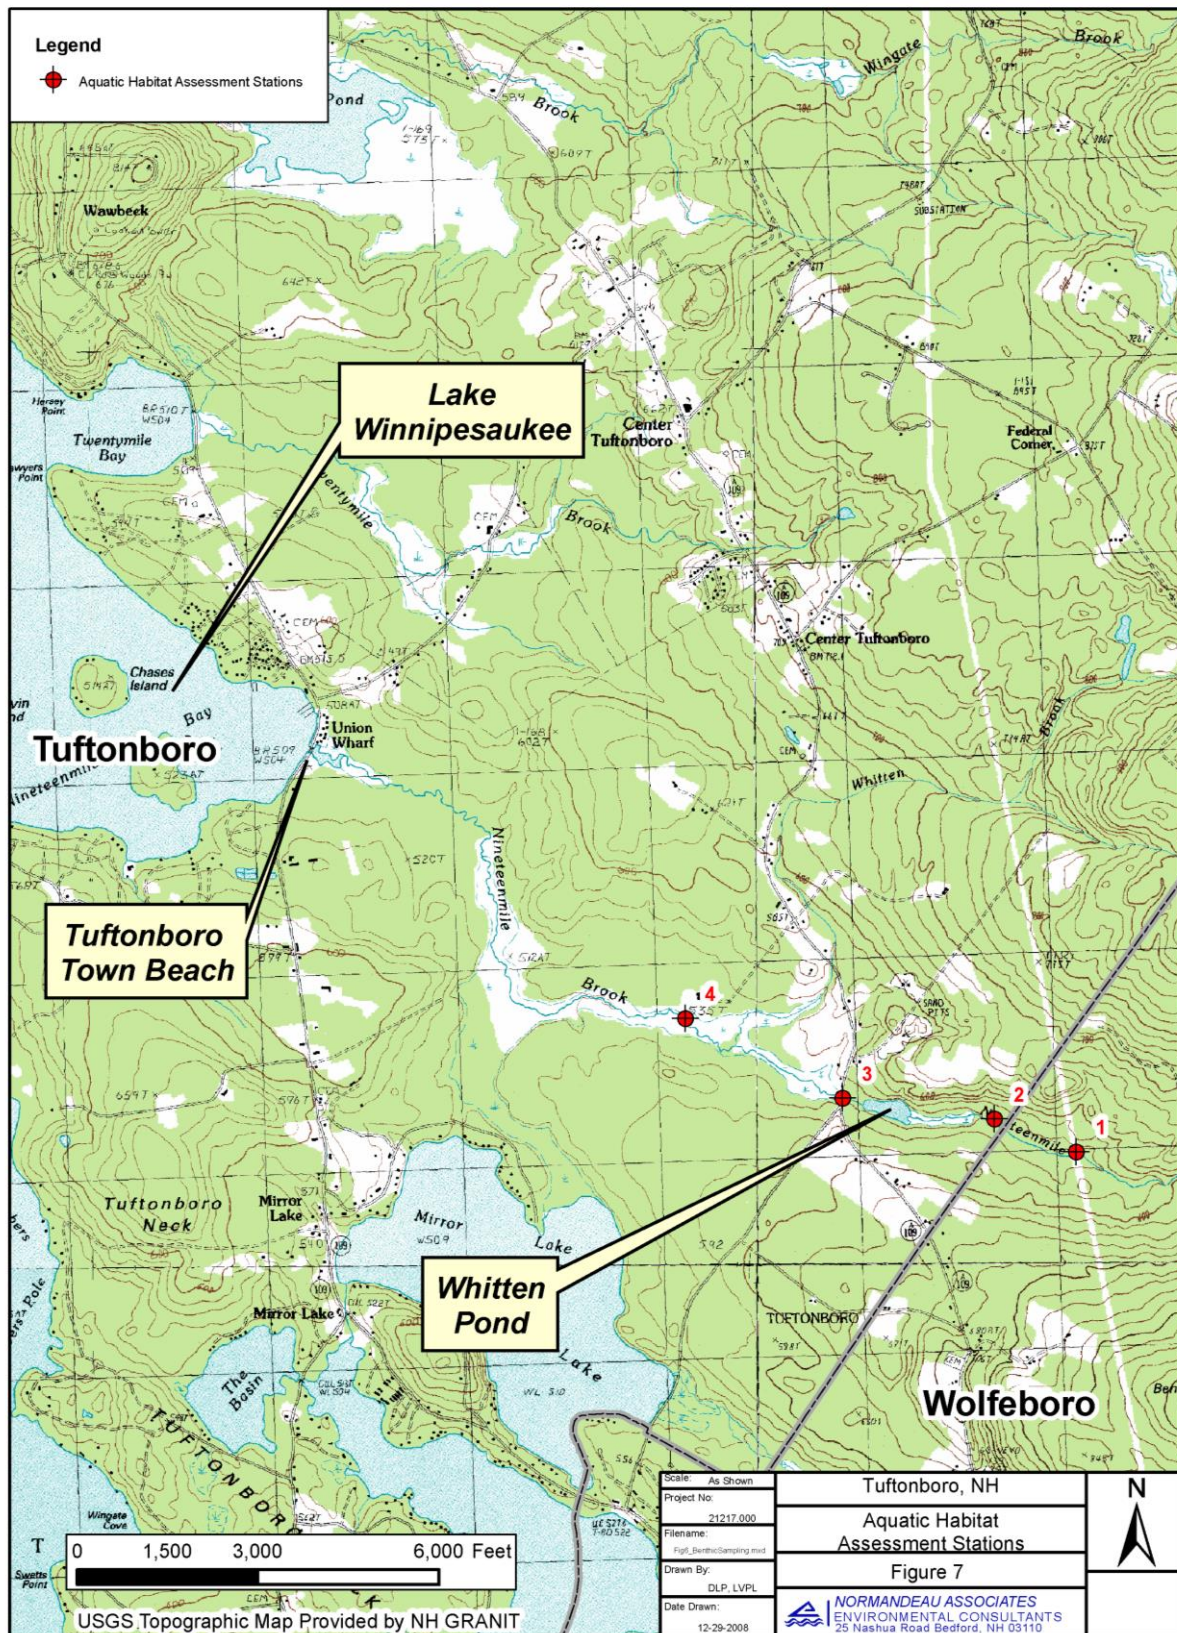
Figure 1. Aquatic habitat/assessment sampling Sites

Surface water quality was monitored during the 2019 baseline studies at four sites (see Figure 1) that were also utilized for water quality monitoring during the 2008 baseline studies. The four sites included a reference station (NMB-01) located upstream of the RIB wastewater discharge area, a station located within the RIB discharge area (NMB-02), a station in Whitten Pond below the discharge (WP-01), and a station in a “recovery” area at the Route 109A bridge (NMB-03). The water quality field program commenced in May 2019 and concluded in September 2019 to include a range of stream conditions and operating conditions from the RIB wastewater discharge.

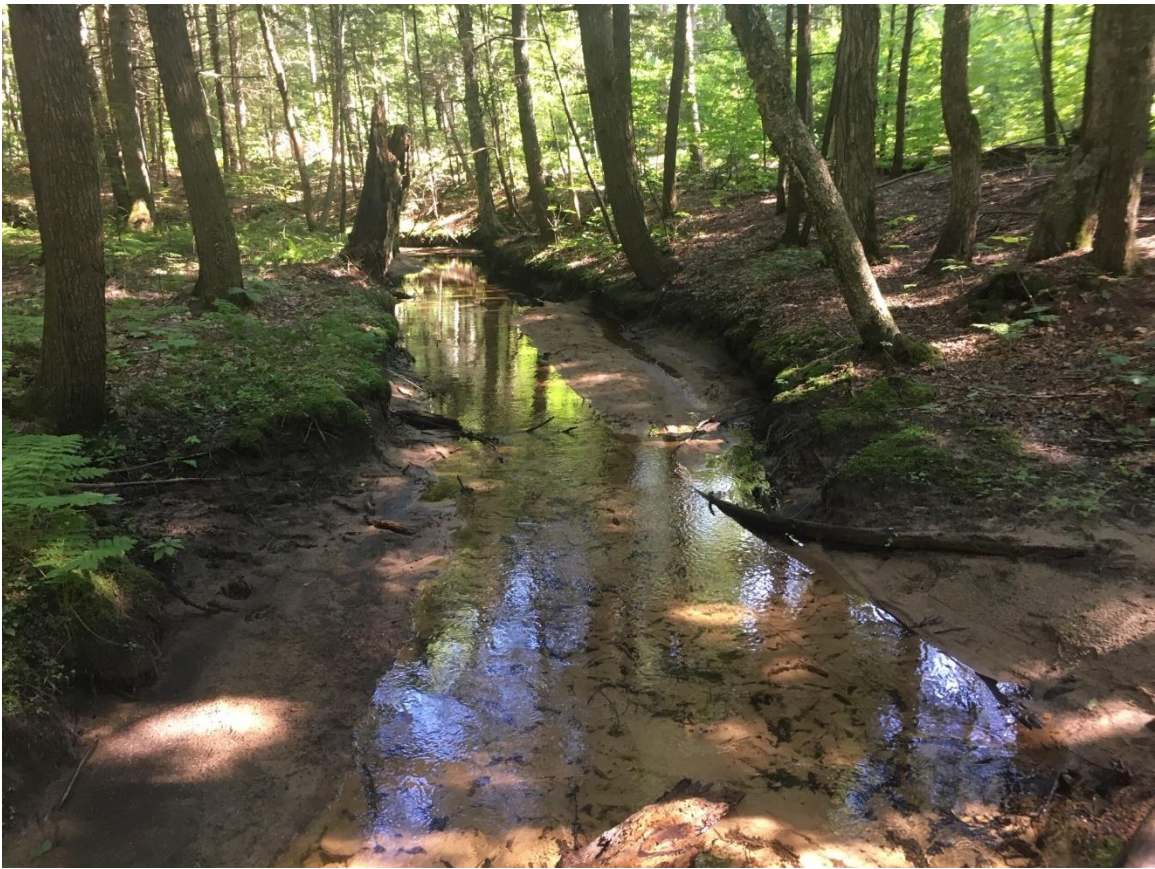
Figure 2. Low Gradient Sandy Habitat in Site 4, August 2019.

Site RBP-4 (also referred to as Site 4) was accessed August 14, 2019 and is the station furthest downstream of the rapid infiltration site and located more than halfway down the main stem of Nineteen Mile Brook. The stream at this location is low gradient with multiple braided channels and ponded sections impounded by beaver dams (Appendix A, Figure 7). This site had an average depth of 1.6 feet in the thalweg and a current velocity of 0.6 fps. Sand and silt were the substrates present at this site and little LWD, CPOM, or FPOM. Aquatic vegetation was present along the entirety of this site in the form of rooted emergent, submergent, and floating plants as well as attached algae. The stream was mostly open, the banks vegetated by herbaceous and woody vegetation but lacking tree canopy cover. Water temperature at the time of sampling measured 17.8°C with dissolved oxygen levels of 9.3 mg/L. The stream at this site runs through an open alder and grass vegetated swamp and does not show any outward signs of human disturbance or habitat degradation due to pollution. The RBP metrics for this site were high (173 of 200) indicating the aquatic habitat at this location is excellent for macrobiota. This scoring is somewhat higher than the value provided for the reference site (173 versus 159), although both sites are considered to have excellent habitat and therefore no aquatic habitat degradation is evident at this site.

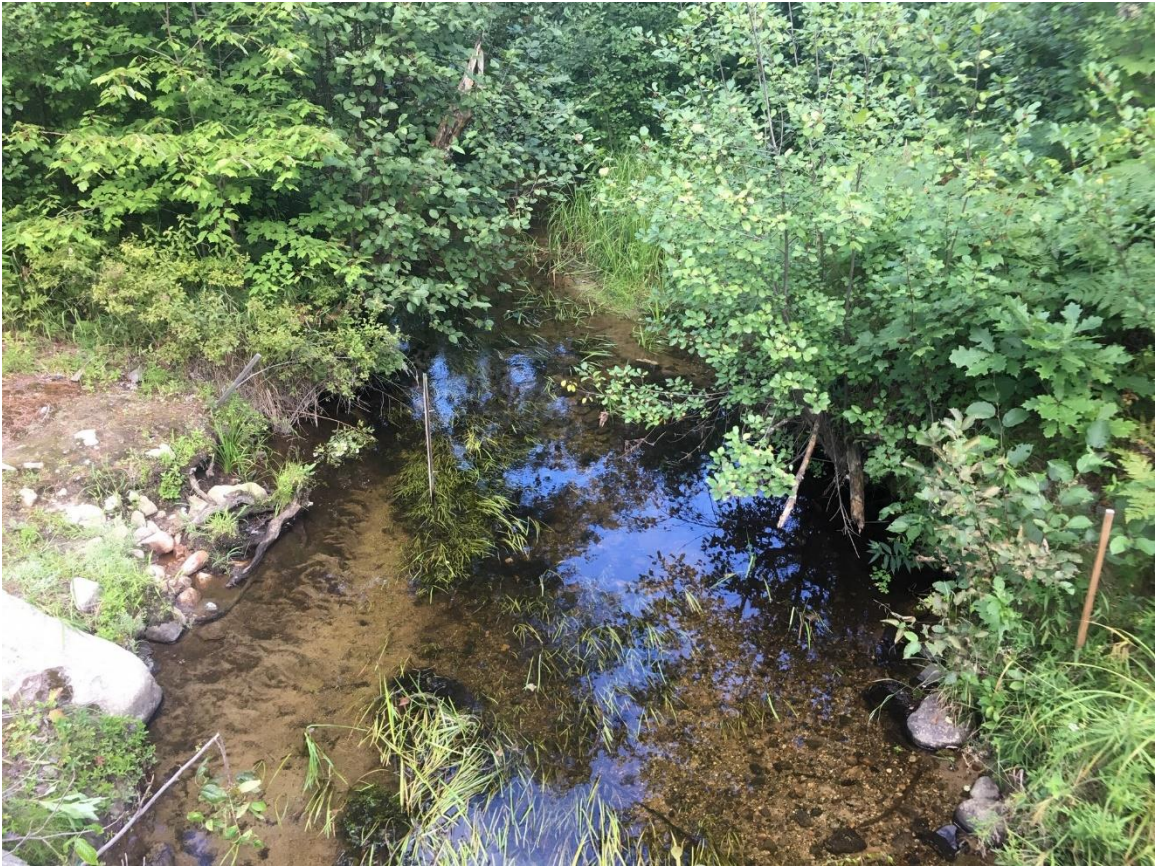
Figure 6. Bottom of Site 2 displaying Sand/Gravel substrate and aquatic vegetation, August 2019

Site RBP-2 (also referred to as Site 2) was accessed August 13, 2019 and is the closest to the RIB discharge area, where biological impacts would theoretically be greatest. This low/moderate gradient reach was characterized by riffles and pools with predominantly sand and cobble substrate (Appendix A, Figure 4). Similar to Site 1, the reach was well shaded by canopy cover along the shoreline and lined with herbaceous and woody vegetation. Patches of LWD in the form of fallen logs and snags were noted throughout the reach with small amounts of CPOM and FPOM present. Average thalweg depth at Site 2 was 0.7 feet with a channel velocity of approximately 0.4 fps. The water temperature as measured at the time of sampling was 15.2°C with dissolved oxygen levels of 10.0 mg/L (Table 3). Outside of the snowmobile bridge crossing at the downstream end of the reach, there were no outwardly visible indications of habitat disturbance or degradation from pollution evident during the survey. The RBP metric scoring for this site was 163 of 200, indicating excellent habitat value for aquatic biota. This scores similarly to the upstream reference reach suggesting that there is no habitat degradation when compared to the upstream reference location.

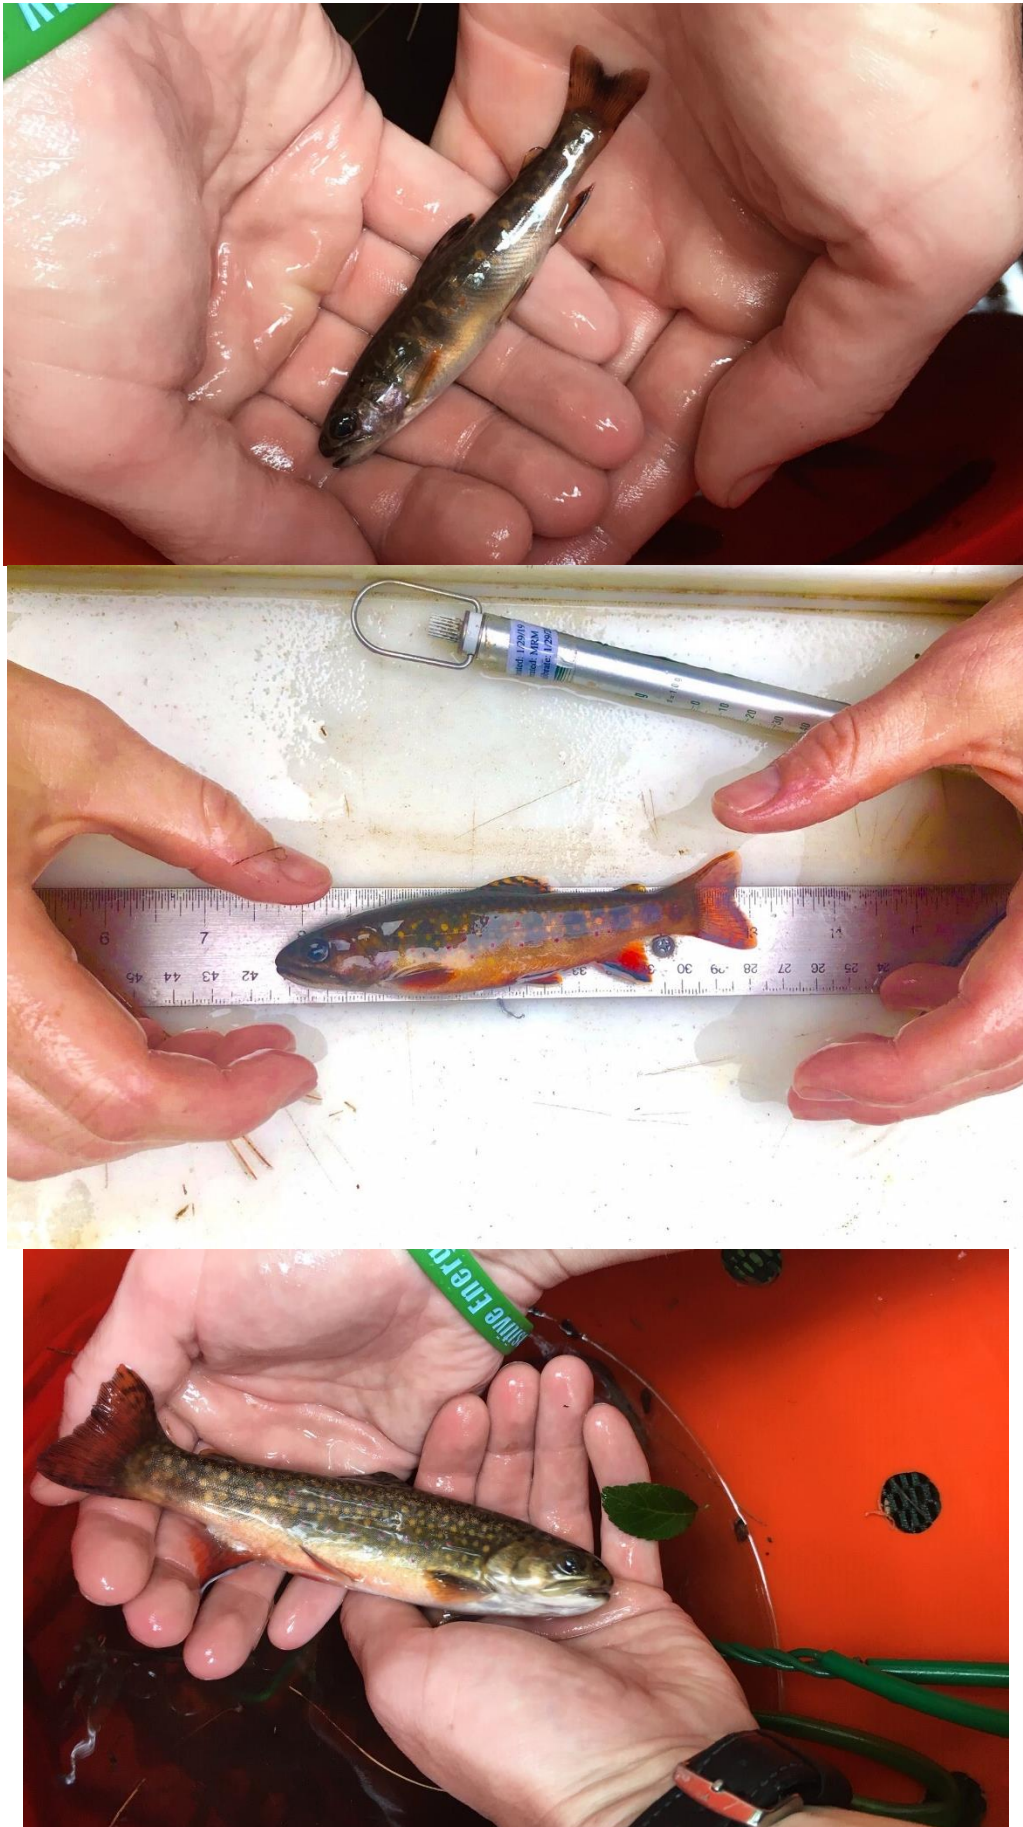
Figure 8. Multiple age classes of Brook Trout captured in Nineteen Mile Brook, Tuftonboro NH, August 2019.

The reference site (Site 1) and Site 2 (the location of the rapid infiltration site discharge) both had similar fish communities. Brook trout (*salvelinus fontinalis*) were the only fish captured at each site. Sixty brook trout were captured at Site 1 representing multiple age classes (sizes ranging from 75 mm to 157 mm TL; Appendix A, Figure 8). Sixty seven brook trout were collected at Site 2 representing multiple age classes (ranging in size from 63 mm to 199 mm TL). The presence of brook trout as the dominant species is typical of a small coldwater stream in NH. Multiple age classes present in the fish population further indicates natural reproduction and multiple-year survival rates. These population characteristics require supportive spawning and rearing habitat with high water quality and are evidence of an overall high quality stream environment. Nineteen Mile Brook is stocked annually with hatchery-reared trout; however, it is unlikely that the fish caught in this study were hatchery-reared. Nineteen Mile Brook is stocked with “1 year+” hatchery fish that would be larger than most wild trout (> 180 mm) and hatchery fish often have fin deformations due to the confined hatchery conditions. The majority of trout caught for this study were well under 180mm in length and showed no evidence of fin deformations and, therefore, were most likely wild trout.
