**Nineteen Mile Brook
2019 Baseline Environmental Assessment
Aquatic Biota and Water Quality
Tuftonboro, NH**

Submitted By
Normandeau Associates, Inc.
25 Nashua Road
Bedford, NH 03110-5500
603.472.5191
www.normandeau.com

February 11, 2020

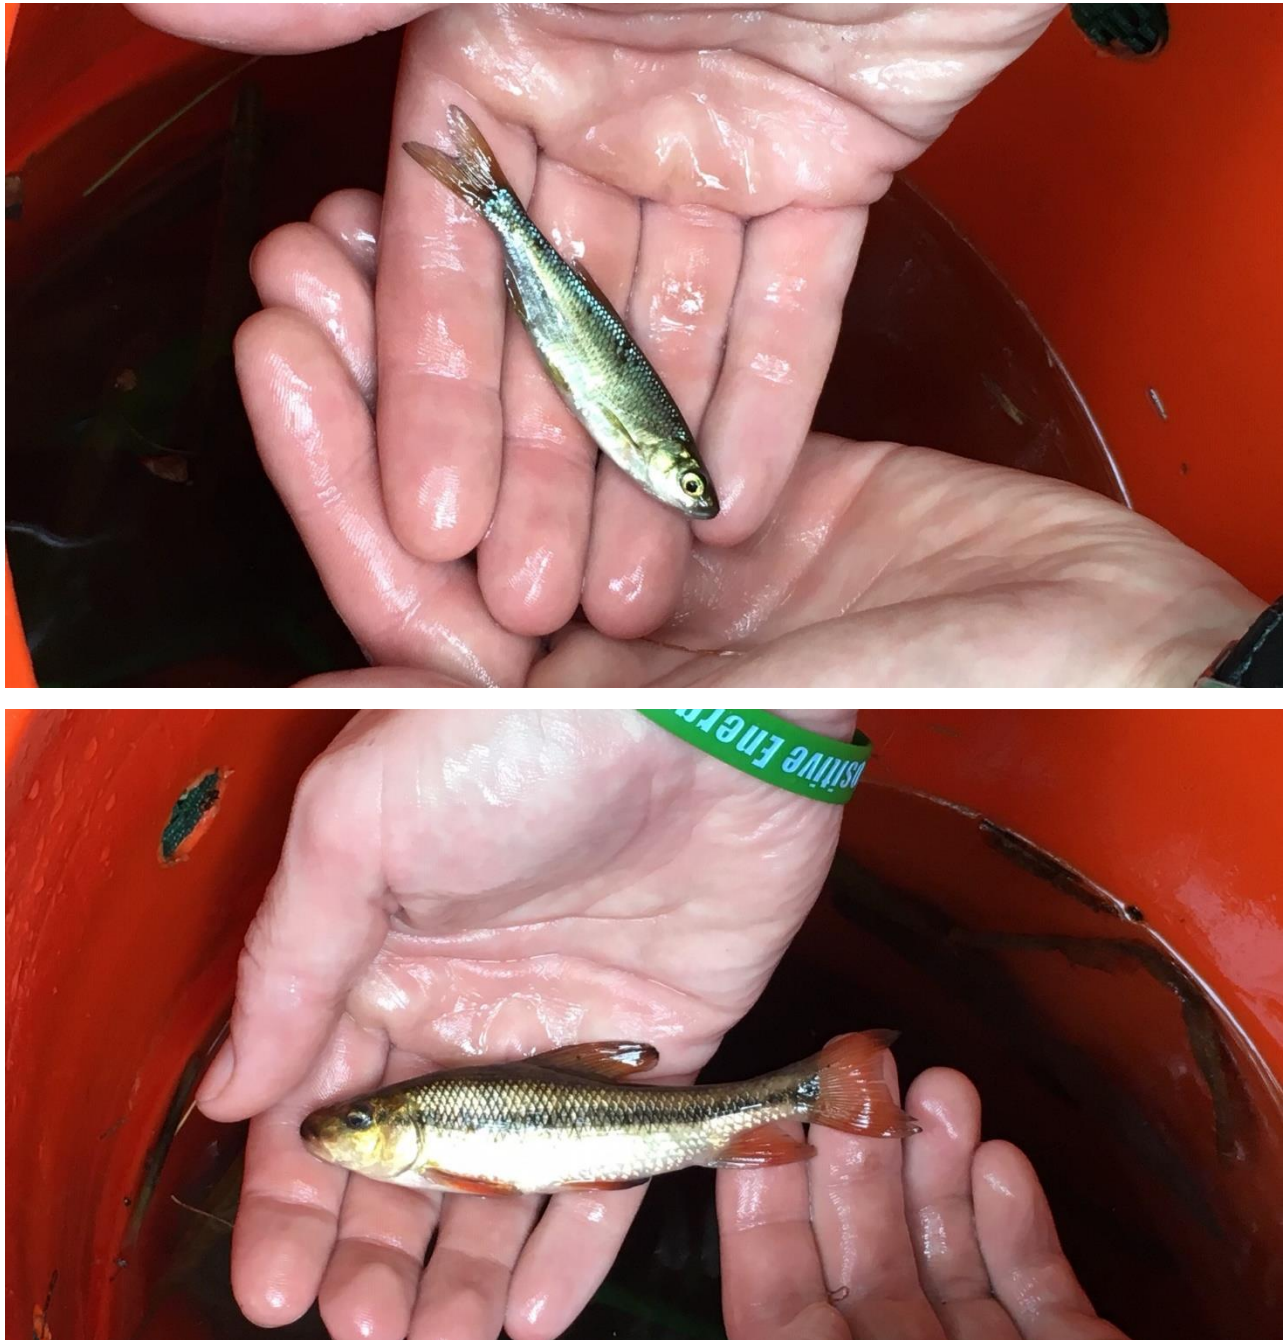
Figure 9. Golden Shiner and Eastern Creek Chubsucker collected at both Sites 2 and 1, August 2019.

Fifty three fish representing five species were captured during sampling at Site 3 (downstream of Whitten Pond). Warmwater and coolwater species were numerically dominant at this location with golden shiner (*notemigonus crysoleucas*) the most commonly encountered species (n=20) followed by eastern creek chubsucker (*erimyzon oblongus*), (n=11; Appendix A, Figure 9). Brook trout (n=9), a coldwater species, were present here representing multiple age classes (lengths ranging from 82 mm to 170 mm). Chain pickerel (*esox niger*) and pumpkinseed (*lepomis gibossus*) were also captured at this location (Appendix A, Figure 10). This site represents a transitional stream environment with warm and coldwater species dominant and our data show this site supports a high quality fish community and further indicates high value habitat and high water quality.

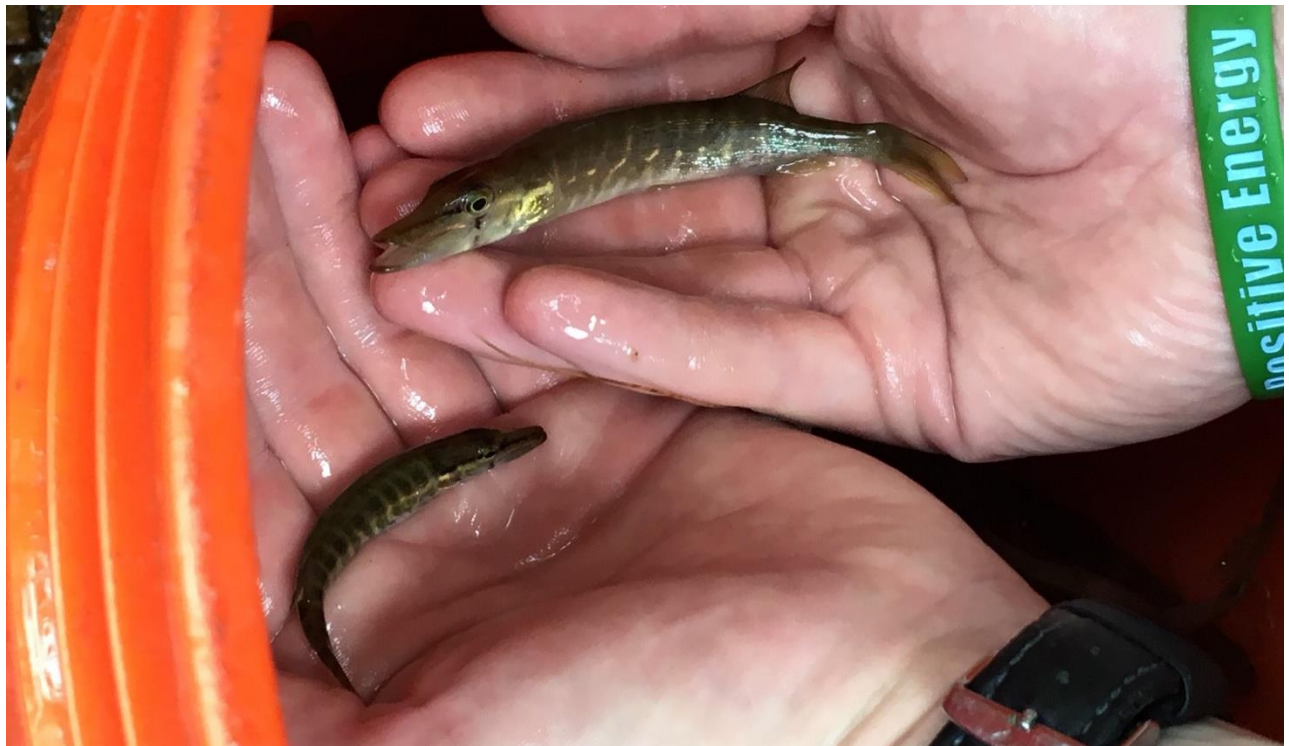
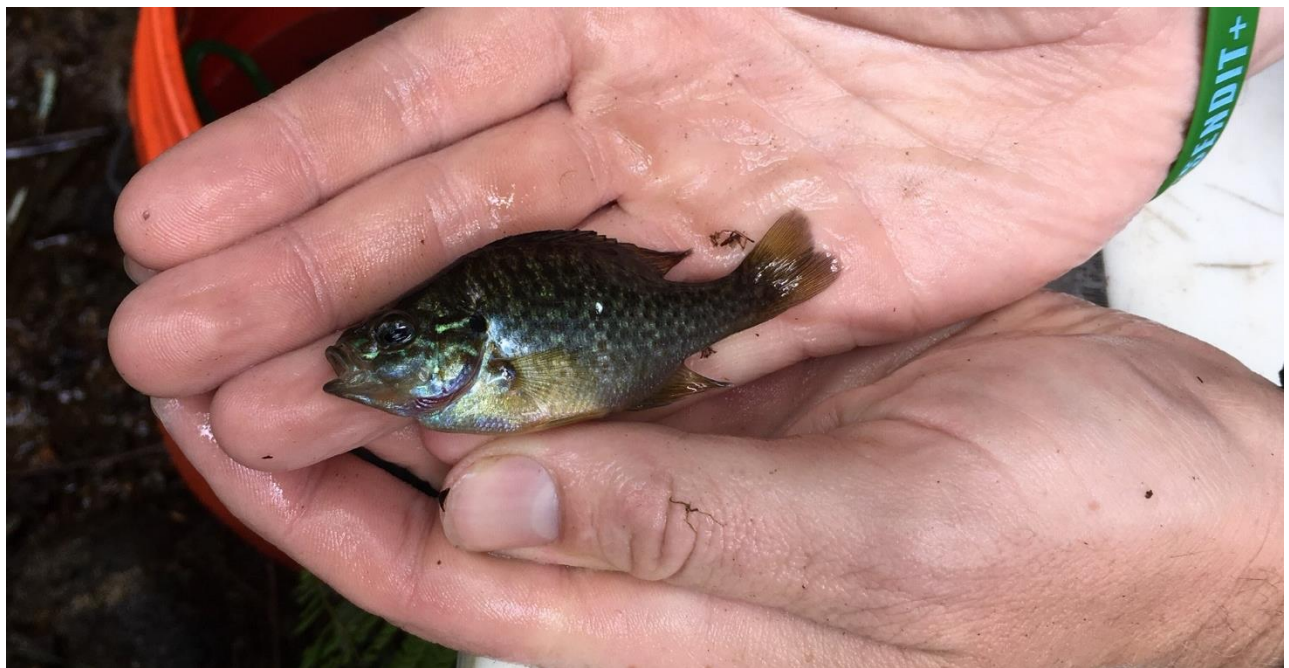
Figure 10. Pumpkinseed and Eastern Chain Pickerel collected at both Sites 2 and 1, August 2019.
